Elemental Analysis of Bricks from the Peter McCutcheon House

In the fall of 2008, Birchwood Archaeological Services undertook an archaeological data recovery at the Peter McCutcheon Farm Site. This site is comprised of the remains of a mid 18th century brick house located in the town of Bethlehem in rural Albany County, NY. Bricks recovered from these excavations were subjected to elemental analysis using X-ray diffraction (XRF) in order to address key questions we had about the site. Results of the brick analysis from the McCutcheon house provide examples of the kinds of questions and research that can be addressed by examining often neglected materials, such as brick, through the use of XRF. A comparison of bricks with clay samples taken from a pond adjacent to the house suggests that most of the bricks were likely manufactured on site, potentially making the pond one of the earliest landscape features at the site. Results indicated that smaller bricks recovered from the base of the north fireplace were compositionally similar but not identical to the larger "moppen" bricks that comprise the fabric of the house, suggesting that they may have been manufactured in another location

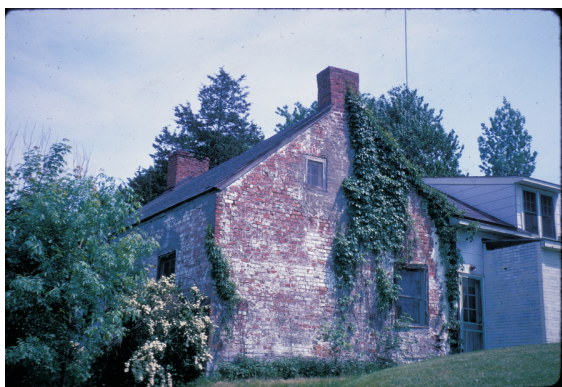
Figure 1. This photograph of the north wall of the Peter McCutcheon House was taken by Paul Huey in 1969 and shows a combination of New World Dutch and English influences. By the early 1990s, the house had been abandoned, and in 2003 the north and east walls collapsed. The remaining walls were systematically dismantled and documented as part of the data recovery.

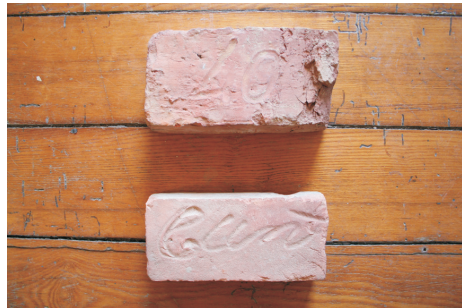
Figure 2. Two of the bricks recovered from the site exhibited hand written inscriptions. One of the bricks was marked "40" while a second brick is less decipherable, but appears to say "cutch"- possibly part of the name McCutcheon. The numbering of the first brick is likely related to the brickmaking process, while the writing on the second brick may represent a name or other word, although not necessarily in English. Both of these bricks were recovered from the vicinity of the south fireplace. This area was thoroughly searched, although no additional marked bricks were identified.

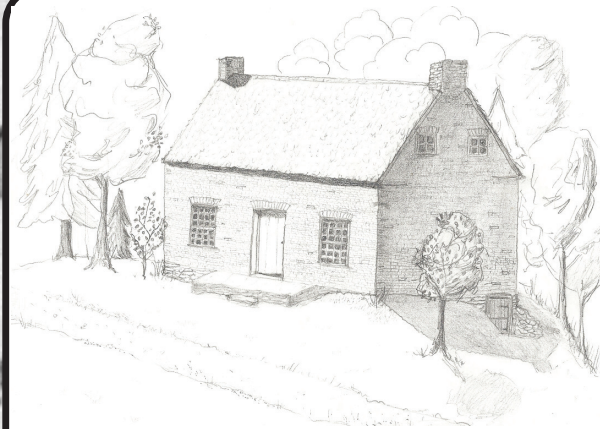
Figure 4. This reconstruction of the front (east) facade of the McCutcheon House is based on archaeological evidence and surviving photographs. Dendrochronology of the structural timbers suggests that the structure was constructed around 1786, the year McCutcheon obtained his lease. Several of the beams dated between 1735-1736, suggesting that some members were recycled from an earlier structure in the vicinity.

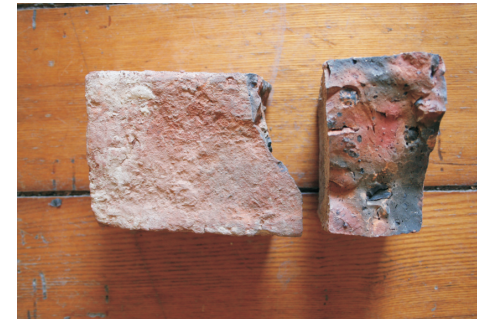
Figure 5. Brick showing dark colored tempering material identified as over-fired brick.

Also tested were dark nodules of temper in a split brick which were originally hypothesized to be coal pebbles. Analysis by the XRF instrument indicated that it was composed of the same elements in the same relative amounts as the above discussed brick samples, and is most likely previously fired waster brick temper.
