Archaeological Investigations at the
Peter McCutcheon Farm Site, Town of Bethlehem,
Albany County, New York

October 2010

A Phase III cultural resources data recovery was conducted at the Peter McCutcheon House Site, located in the Towns of Bethlehem and New Scotland in Albany County, New York. The site is a mid-18th century domestic and agricultural landscape, including a partially collapsed house, a pond, two barn foundations and several landscape features all within an area of approximately 1.26 acres. The Phase III study consisted of a full-scale mitigation of the site with unit excavations, mechanical scraping and structural dismantling in combination with documentary research centered on a series of research questions established in the Data Recovery Plan.

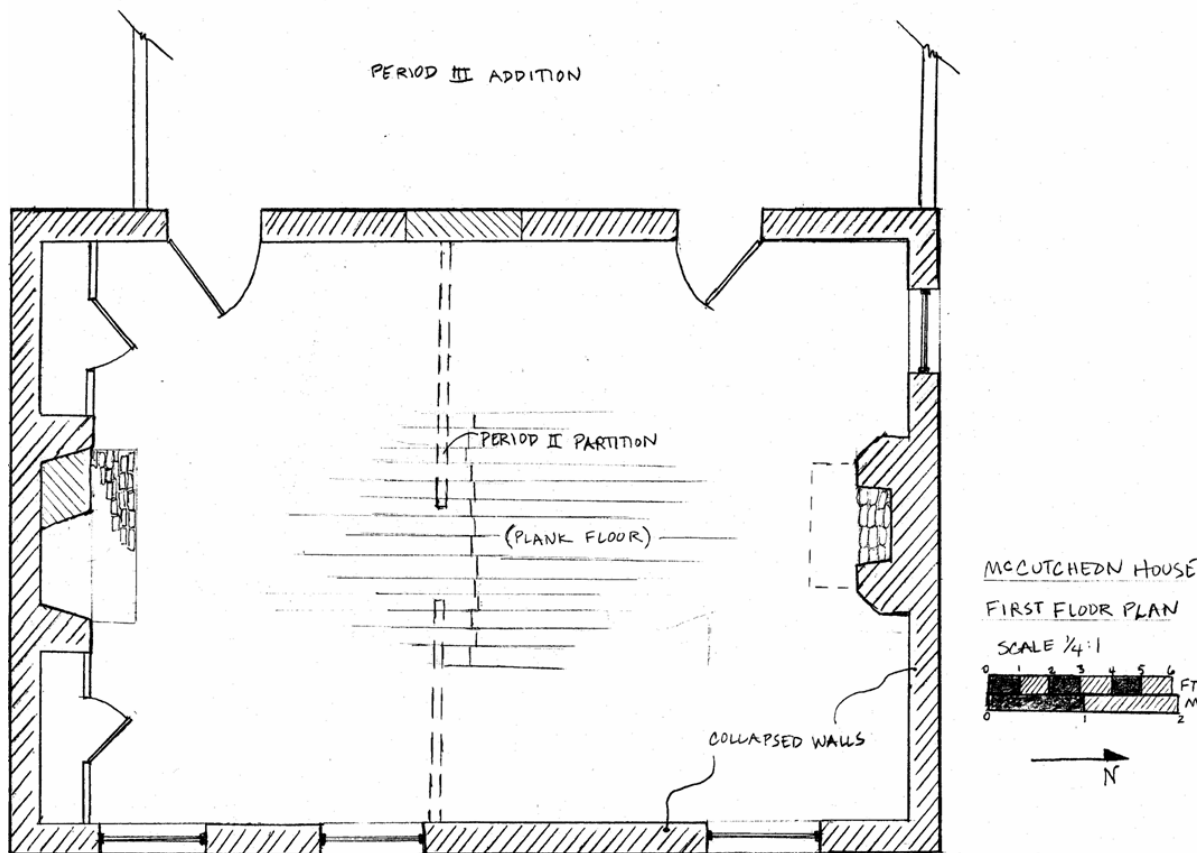
Figure 3. Conjectured First Floor Plan, Peter McCutcheon House.

The west, or front, façade originally contained three openings: a door in the central bay and a window in either outer bay (Figure 3; Photo 3). At the time the house was demolished, only two of the openings remained, the center one being enclosed with the same moppen bricks as are used in the rest of the house's construction. The outer openings were both converted to doorways at some point in the house's history. Most

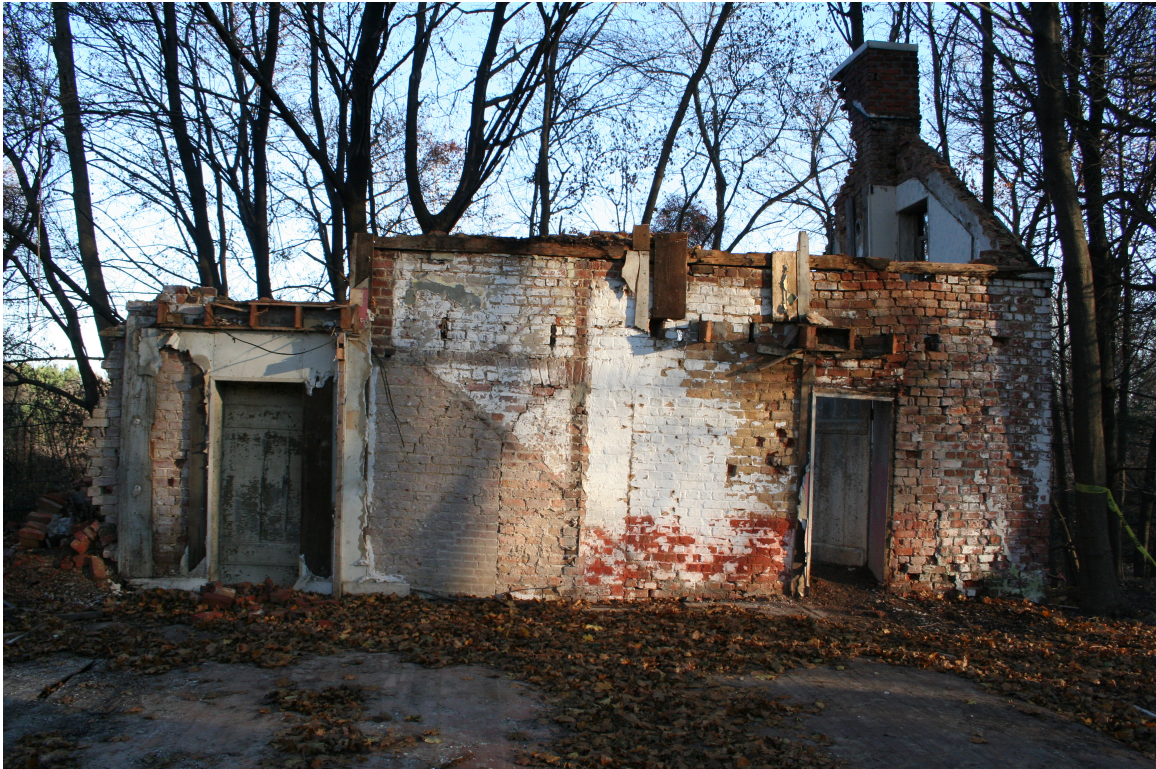
Photo 3 West Façade, Peter McCutcheon House, facing northeast.

recently those doors served as connectors between the 18th- and 20th-century sections of the house. All three openings originally featured a relieving jack arch, however only the original door, now filled in, still retains this arch. Sagging bricks above the original window openings belie the structural weakness caused by the removal of the jack arches (Photo 3).

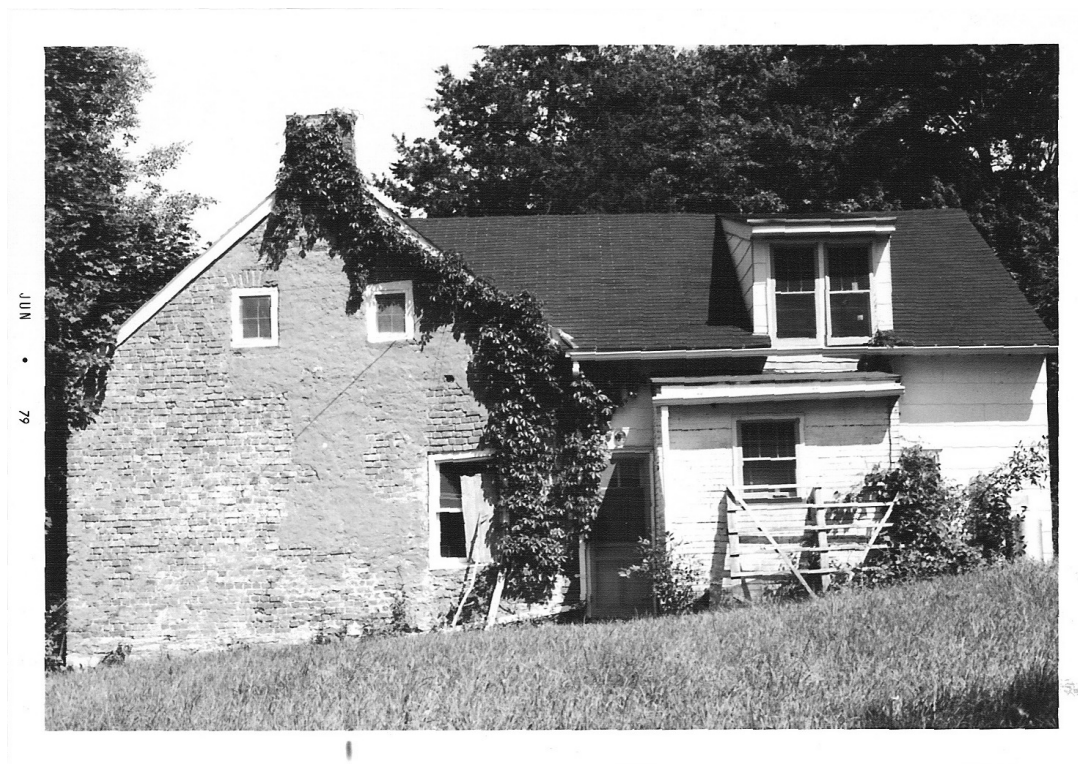
Photo 4. North elevation of the Peter McCutcheon House, facing southeast. Photo by Tabor and Cornell, 1979.

The north gable end of the brick portion of the house was built with one first-floor window opening in the southernmost bay. In the only surviving photograph of the window, it contained a wooden one-over-one double hung sash (Photo 4). Two four-light fixed-frame windows occurred on either side of an interior chimney stack in the upper half story. While the upper windows have relieving jack arches above them, the lower first story window had no such feature. One basement window occurred on this elevation in the southernmost bay. In the only photograph of this elevation, taken in 1979, the basement window is not visible (Photo 5).

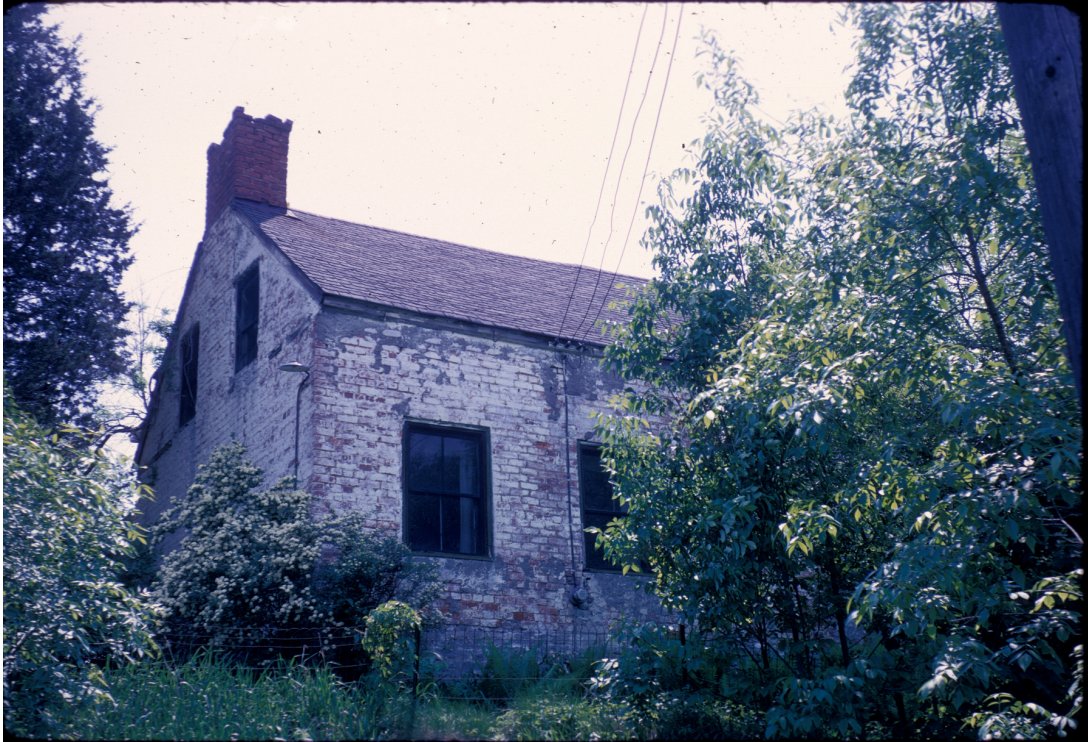
Photo 6. Perspective of the Peter McCutcheon House, facing west. Photo by Paul Huey, 1969.

of this façade. The basement portion of the wall, however, was intact upon evaluation. First floor windows appear in a 1969 photograph (Photo 6) with two-over-two light double-hung sashes of 19th-century vintage, while later photos show these windows boarded over (Photo 5). These first-story windows do not appear to have had relieving jack arches above them. Two windows within the foundation on the basement level are exposed on this elevation as the bank recedes. A wire hardware mesh remains across the westernmost basement window (Figure 4).

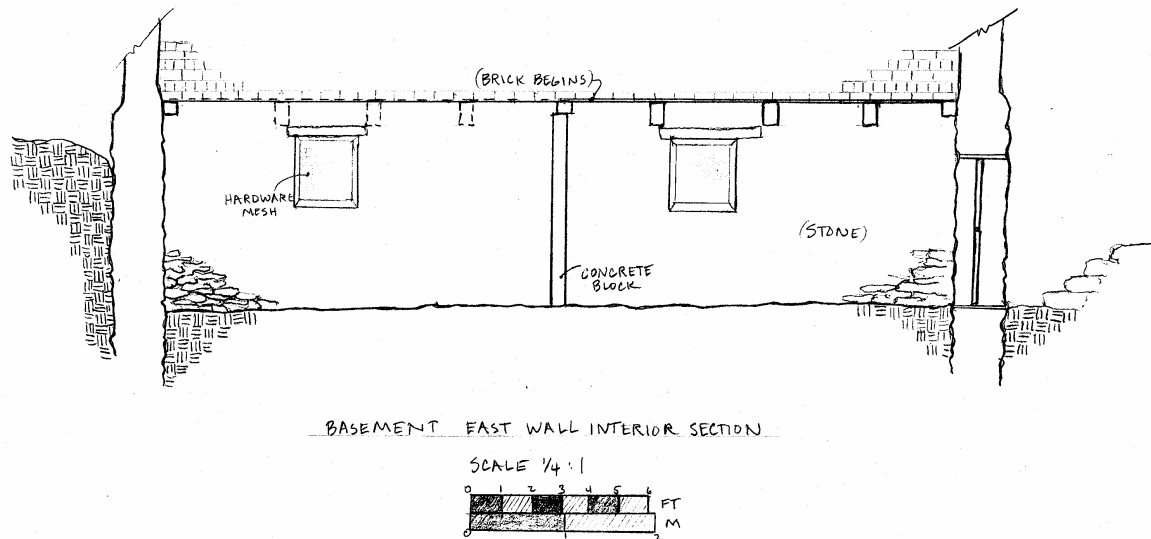
Figure 4. Basement east wall elevation drawing showing stone foundation, windows, and exterior door on the southern wall.

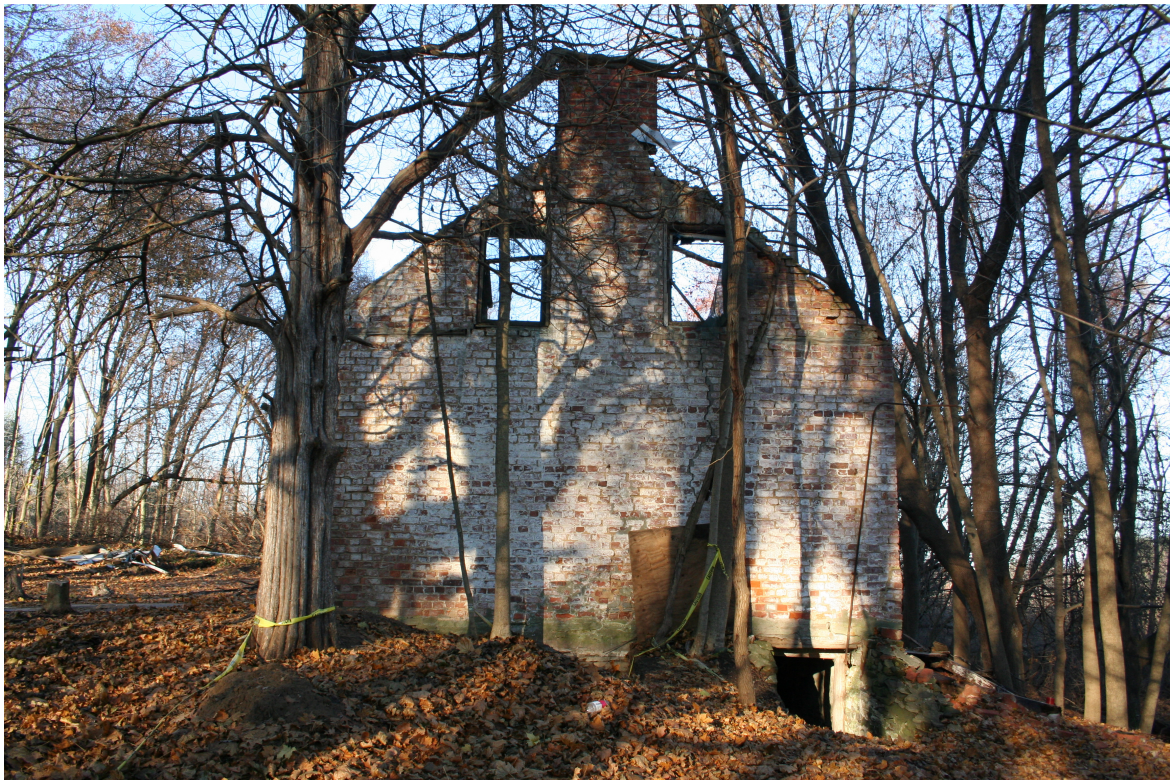
Photo 7. South elevation of the Peter McCutcheon House, facing northwest.

The south gable end façade was still largely intact upon assessment of the building. Only two windows occur on this elevation located on either side of the interior chimney stack in the upper half story. The placement of these windows is very similar to those in the upper half story on the opposite end; however, they are depicted in 20th-century photographs as having six-light fixed or casement frames. These windows may have originally been small four-light windows as on the other gable end and possibly lengthened in a later construction episode. In addition to the windows, the only exterior access to the basement occurs on this elevation in the northernmost bay. Four stone steps descend below grade to a two-part horizontal door commonly associated with Dutch building practices. The door had been removed by the time of mitigation, but historic photographs and existing hardware confirm its original presence (Photos 33 and 34).

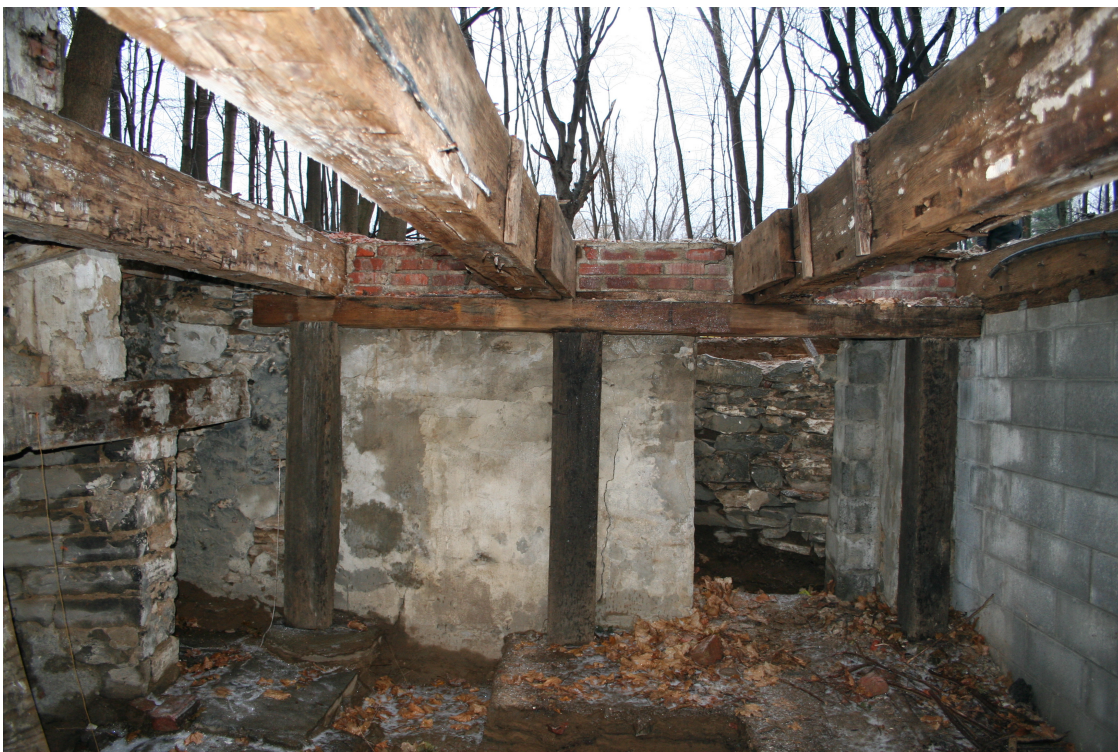
Photo 8. Basement excavations at the Peter McCutcheon House, facing southwest.

The basement, however, became increasingly clearer with full-scale excavations that took place during the mitigation (Photo 8; Figure 5). Encased in an uncoursed stone foundation, the space is divided in half by a modern concrete block wall likely put in as a replacement for an earlier, load bearing masonry partition. The southernmost room is dominated by a massive stone hearth (Photo 9). The fire place was originally seven feet wide and two-and-a-half feet deep. Because of its massive firebox, this hearth was undoubtedly used for heavy domestic work including cooking, laundering and food preservation. Situated between the hearth and the southern exterior wall is an alcove that may have originally served as food or wood storage. The large, hewn mantelpiece extends across the alcove until it terminates at the southern wall. On the opposite side of the hearth between the stack and the northern exterior wall opens the only exterior access from the basement. The walls in this room and throughout the basement are whitewashed. The ground in the hearth room appears to have been planked except where large hearth stones extended into the room. A number of domestic artifacts were recovered from this area which will be discussed in subsequent sections.

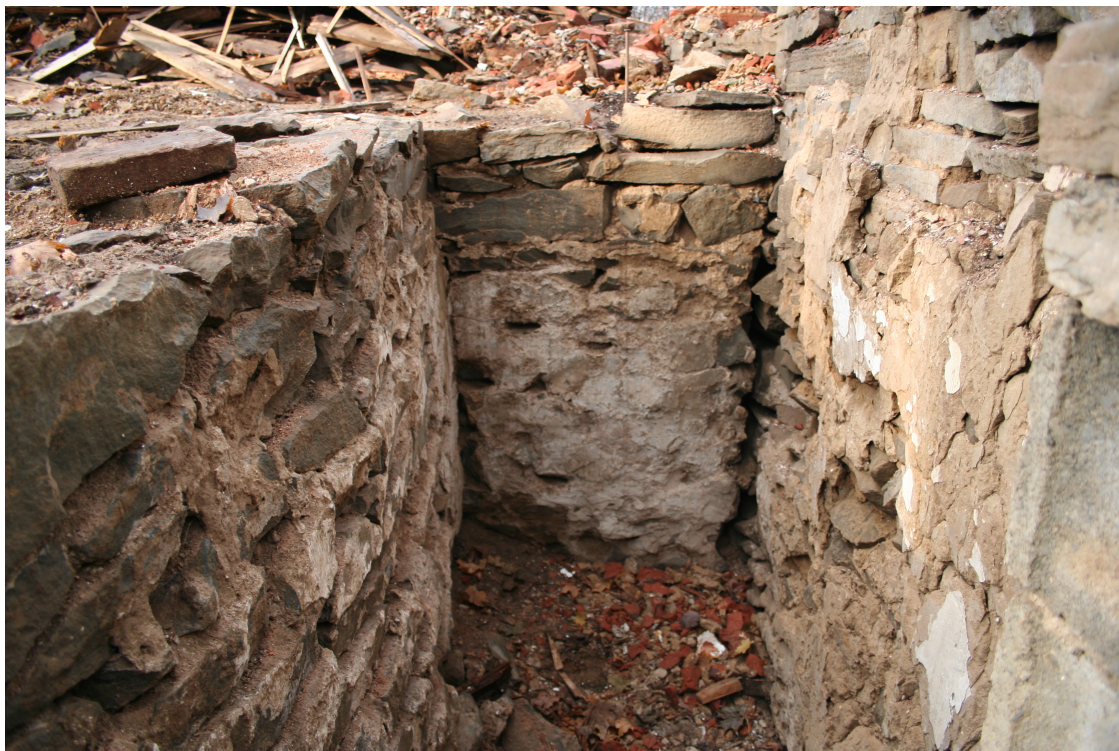
Photo 11. Small room beneath porch foundation on the west side of the basement, Peter McCutcheon, facing northwest.

A third room in the basement extends off the southern wall and forms the foundation for what would have been a small porch off the front elevation of the house (Photo 11). The small room had no evidence of formal flooring, yet the stone walls were once covered in white wash suggesting the room had an appointed purpose, perhaps as dairy or other food storage. White wash not only makes dim surfaces more visible, it allows surfaces to which it is applied to be cleaned more easily. The size of the room, 9 x 4 ft (2.7 x 1.2 m) would have reduced its practicality to storage. The porch foundation and the room it creates in the basement appear to be original to the house.

As mentioned previously, a small, rectangular porch foundation was accessed from the west wall in the southern half of the main cellar (Photo 11). This foundation measured approximately 4 ft by 10 ft (1.2 m x 3 m). Two 1 x 1 m square excavation units were excavated in the floor of the porch foundation as shown in Figure 7. This encompassed approximately two thirds of the interior space, in keeping with the data recovery of the main cellar. A total of 346 artifacts were recovered from the interior of the porch foundation (Table 3). Architectural material made up nearly half of all of the artifacts recovered (43.6%; n=151), followed by food remains (n=65; 18.8%) and domestic refuse (n=56; 16.5%). Lesser represented functional artifacts classes include beverage consumption (N=12; 3.4%), lighting (n=11; 3.2%), personal (n=9; 2.6%), medicinal (n=4; 1.2%), and farm/transportation related (n=1; 0.3%). The high amount of architectural material is not surprising, since it would appear that refuse collected in the bottom of the porch foundation as a result of the demolition of the modern wood framed addition. No early architectural artifacts were recovered. Instead, more recent artifacts including window glass, wire and machine cut nails, asphalt roofing and brick and mortar rubble were recovered. What was surprising was the high number of food remains and domestic material. Ceramics recovered from within the porch foundation include sponge decorated, “mocha,” and red and blue transfer printed whiteware, Jackfield style coarse earthenware, and undecorated pearlware and porcelain fragments. Most of the ceramic assemblage appears to date between the late 18th and mid-19th centuries, suggesting potential refuse disposal practices taking place in this area during that time. Our initial

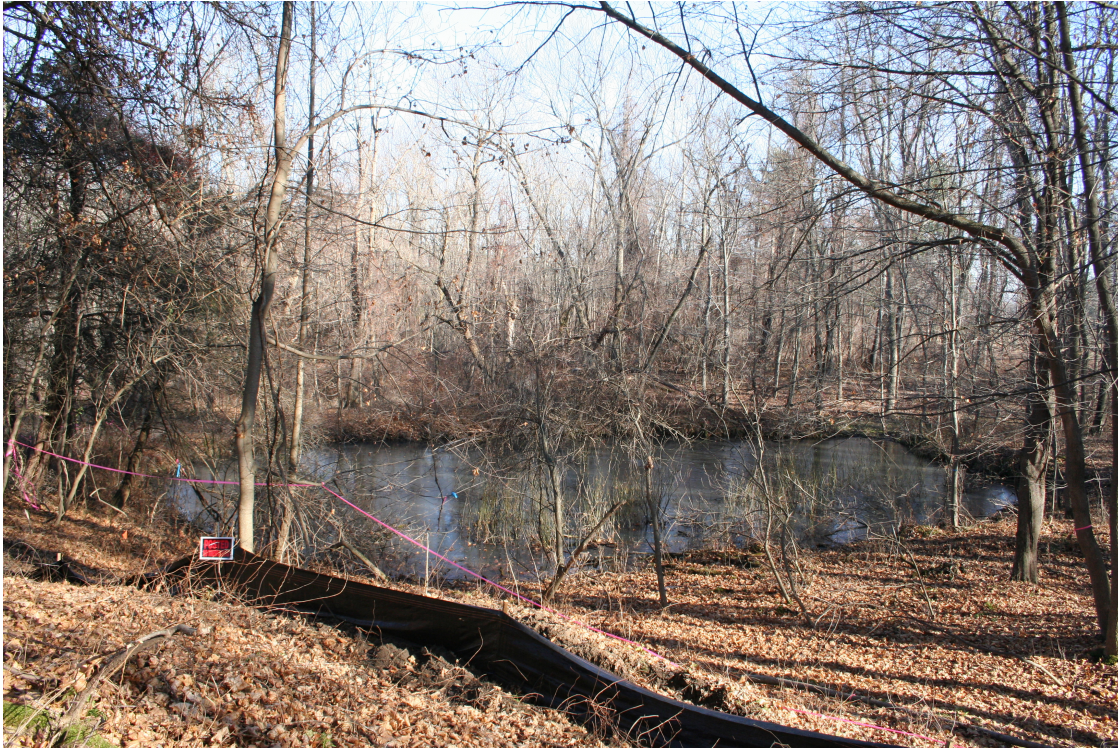
Photo 12. View of pond below house, facing northeast.

The pond located to the south of the house may have provided water for the house and/or livestock (Photo 12). A two inch diameter iron pipe leads from the pond into the slope toward the house above, which may have been used to pump water. Conversely, it may have been used as a stock pond to water livestock, although additional sources of clean

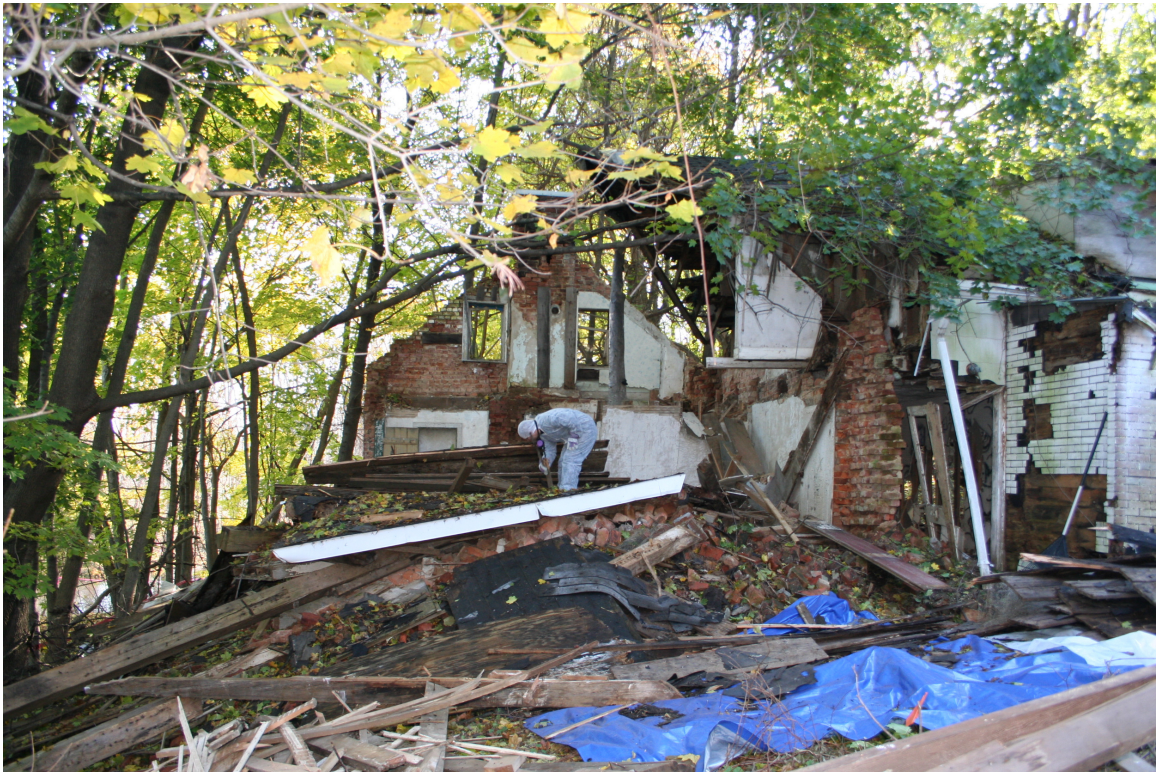
Photo 14. View of structural dismantling and asbestos abatement process, facing southeast.

After the debris from within the cellar was removed, the abatement turned to the demolition of the 20th century wood framed addition. The removal of the addition posed two problems. Because the wood framed addition was attached to the original front façade of the house, it was unclear what the front of the house originally looked like, since the addition appears in even the earliest known photographs. Therefore, we wanted to carefully remove the addition to allow us to photograph the original front façade prior its imminent collapse, as it had become structurally compromised as part of the abatement.

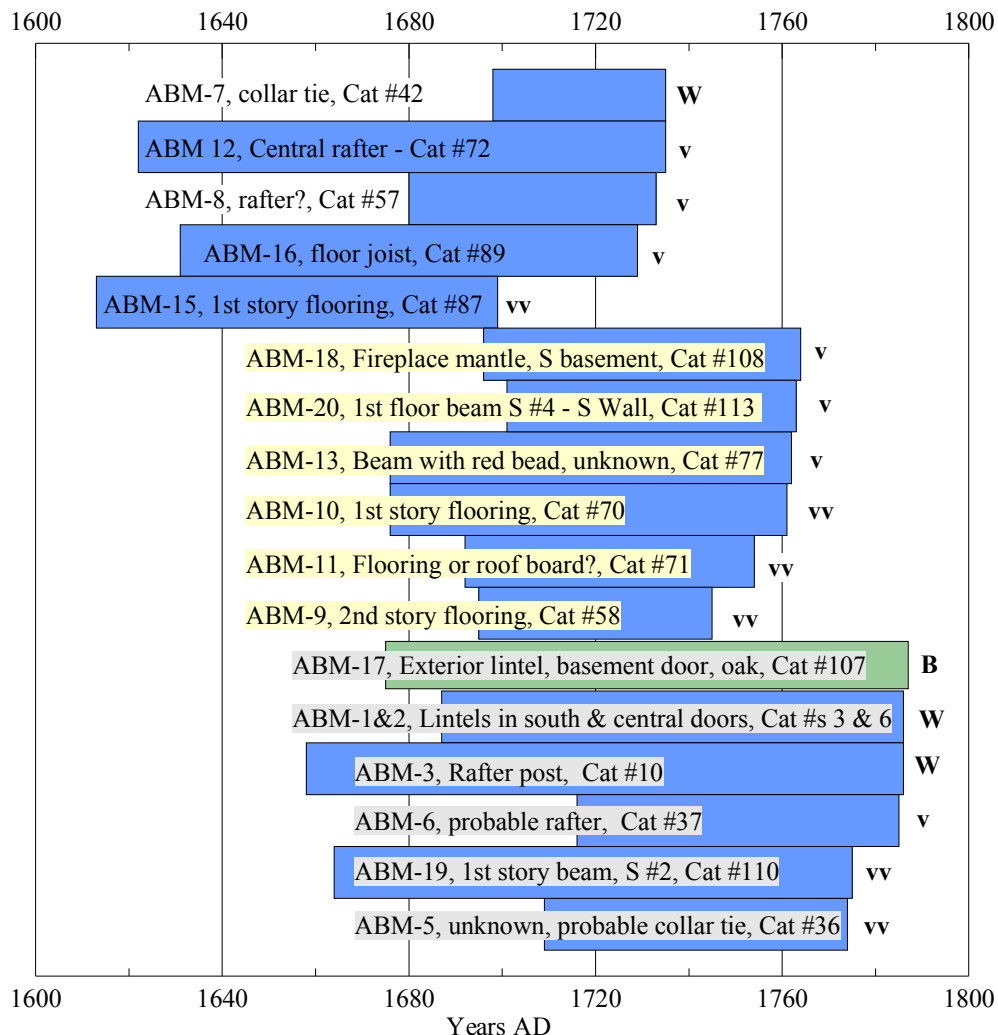
Table 2. Ranges of dates covered by each dated sample. Blue bars indicate pitch pine samples; the green bar represents the one oak sample. For a full explanation of these findings, see Appendix F.

Ms. Griggs' analysis found that there were three building episodes represented in the samples she reviewed (Table 2). The first building episode occurred around 1735. Timbers estimated to date from this period included a collar tie, a central rafter, a floor joist and first floorboard. The second period represented in the dendrochronology results is estimated to date around 1764. Timbers from this phase consist of the basement fireplace mantle, a first floor joist, two pieces of floorboard (one from the first and second floors), a possible floorboard or roof board, and an unknown beaded beam. The third and final phase occurred around 1786-87 and contained, in part, wooden members related to fenestration at the McCutcheon House. Lintels above the central and southern opening on the front façade were made from the same tree and date to 1786. In addition, the exterior lintel above the basement door, the ridge beam, a first floor joist and a rafter date to this phase.

The dendrochronology results came as a surprise as the brick portion of the house had appeared to be built in one continuous building period, not three. In consideration of this, several things may be possible. Various timbers from within the brick house may have been reused from earlier buildings on the present or neighboring sites. When this is the case reused timbers often display empty mortises and other uncorrelated construction marks. However, no such marks were noted in the timbers at the McCutcheon House. Another possible cause of the multiple periods is one or more fires or subsequent rebuilding episodes. If the brick shell was built during the earliest suggested period (1730s), fire may have destroyed interior wooden beams at one or two points in the following years leading to a series of replacement beams within the house dating to later periods. However, no obvious signs of fire damage on any construction bricks were noted.

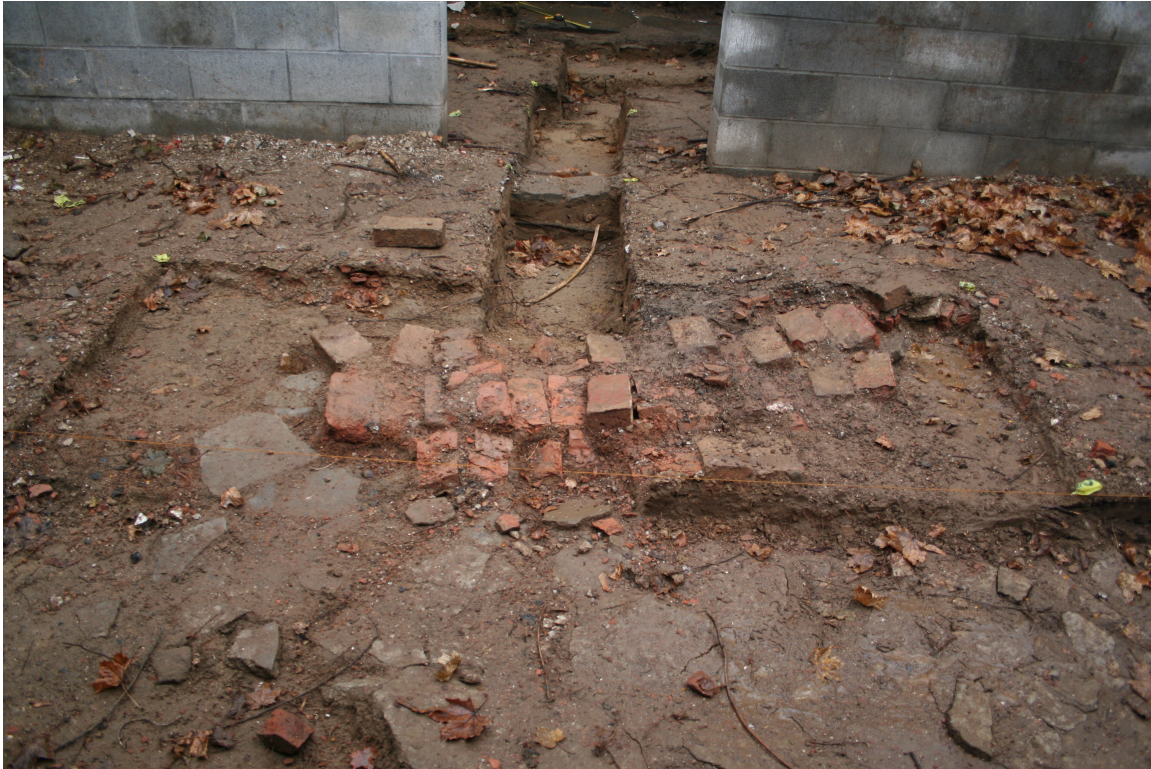
Photo 15. View of brick pavers excavated on the north side of the basement, facing southeast.

Evidence of a possible brick floor was also found in the northern half of the cellar (Photo15). These bricks were unmortared and appeared to run in even courses along three linear rows along a roughly east/west axis. This feature did not appear associated with the cement floor along the northern wall of the house, and was located closer to the modern concrete block wall separating the two halves of the cellar. It was not initially clear if this floor was original to the construction, since it could easily represent someone using bricks to stack objects above the basement floor in the event of flooding or else to fill in a depression and level the floor. Unfortunately, this northern half of the cellar appeared more disturbed, especially in proximity of the recent concrete wall.

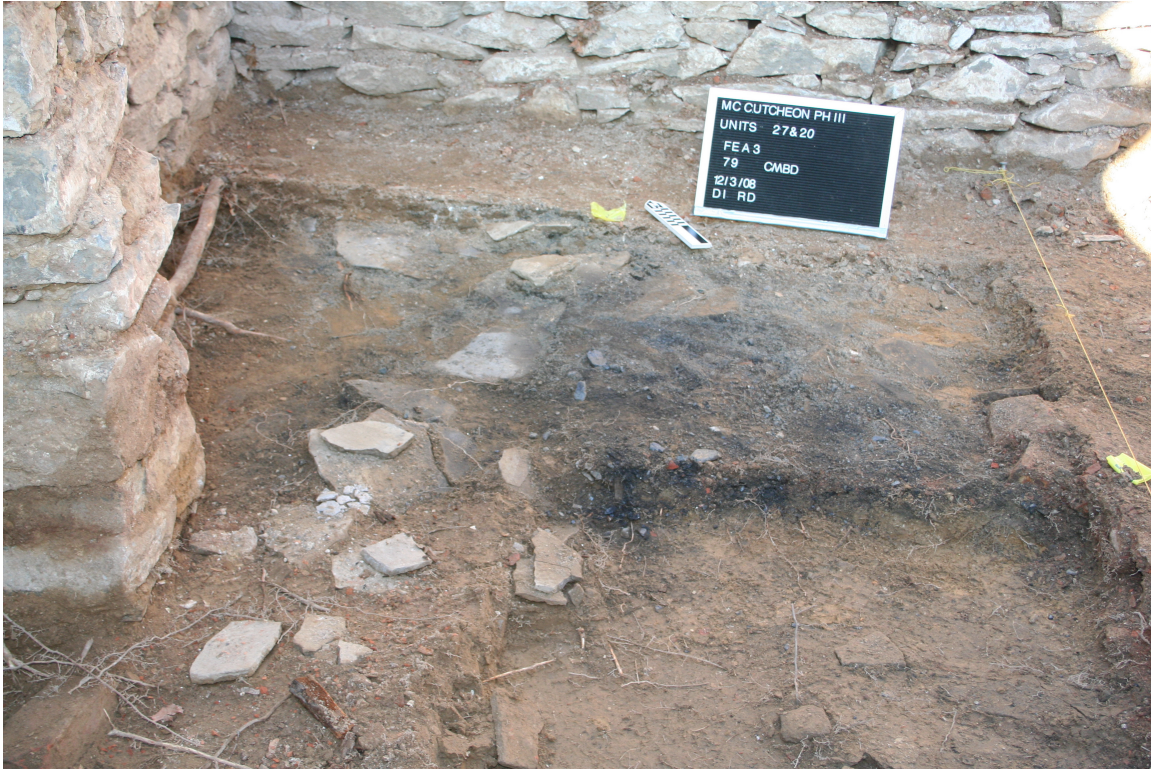
Photo 16. Detail of black coal stain in north section of the basement.

A large, black coal stain was noted near the northeast corner of the cellar extending in front of the supporting arch. This stain measured approximately 162 x 110 cm and likely delineates an area used to store coal. While no evidence of a coal furnace was present in this area it may have been removed at a later date, possibly after the site's abandonment. The furnace might also have been removed during the seasonal occupation of the house by the Reilly family, who came to the McCutcheon house from nearby Albany to escape the summer heat of the city and would not have necessarily required a furnace as part of their use of the property. Additionally, the wood framed addition had a furnace in its utility room, which would have been capable of heating that half of the house if necessary.

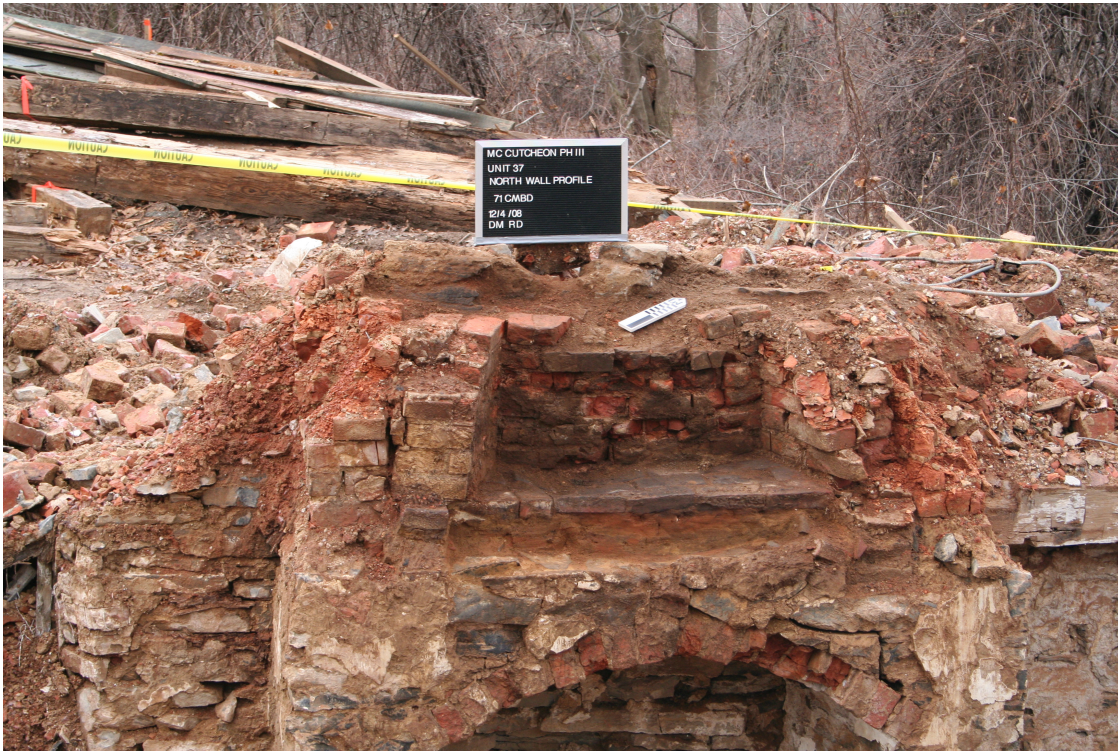
Photo 17. View of north first floor fireplace, Peter McCutcheon House, facing northwest.

Because of the collapse of the north wall prior to the archaeological investigations, there was much speculation about the north fireplace, especially as it compared with the southern fireplace, which we were able to better document. Unfortunately, the north fireplace was located under unstable rubble, preventing our examination. Once the addition was removed, we were able to begin removing and stacking the bricks and wooden timbers covering the fireplace. When the outer fireplace rubble was exposed, we decided to excavate a 1 x 1 m square excavation unit to examine the base of the hearth and its contents (Photo 17). Unit 37 was larger than the fireplace, so the southern 20 cm was not excavated.

Excavation of the fireplace was difficult since the first floor flooring had long since collapsed, causing the excavator to work from the exterior of the house. While we did some excavation from the front of the fireplace using ladders and buckets, this area was deemed too unstable for long term examination. Approximately 45 cm of fill material was excavated from the interior of the fireplace. A small amount of sandy soil mixed with brick dust and mortar rubble made up the soil matrix. No artifacts were recovered from the fireplace fill. Excavation stopped at the base of the bricks, and the fireplace was photographed (Photos 17 and 18) and drawn. Bricks in the floor of the fireplace were unmortared, and were smaller than the “moppen” style bricks that dominate the construction materials, measuring only $7 \frac{1}{2} \times 3 \frac{1}{2} \times 1 \frac{3}{4}$ inches on average. These bricks are more in keeping with common brick sizes of the late 18th and early 19th century as seen in the architecture of the surrounding area.

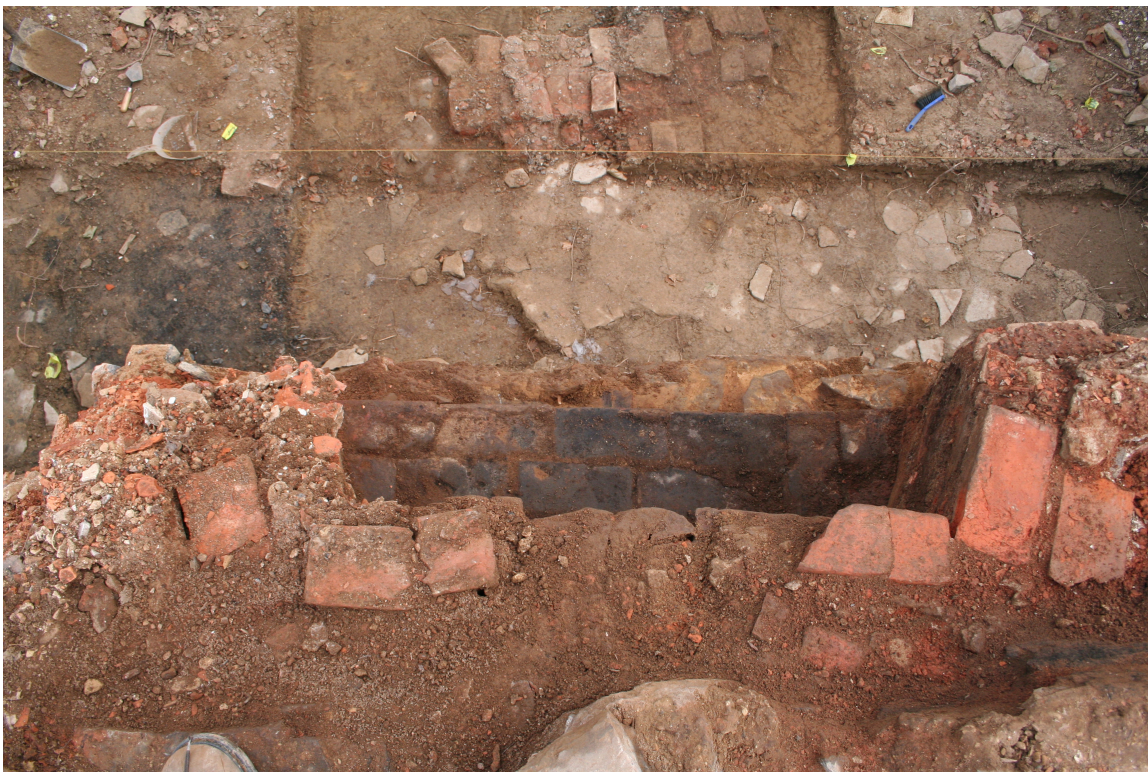
Photo 18. Plan view of north fireplace, Peter McCutcheon House.

After the floor of the fireplace was drawn and photographed, the bricks were carefully removed to look for any material that might occur beneath or between the cracks of the bricks. A common wire nail and a pipe stem fragment were recovered from the fireplace floor during the removal of the bricks, and a small fragment of bone was recovered from beneath the bricks. Because of the small size of the bone fragment, it is unclear if it represents uncarbonized food remains or if it represents post abandonment rodent activity.

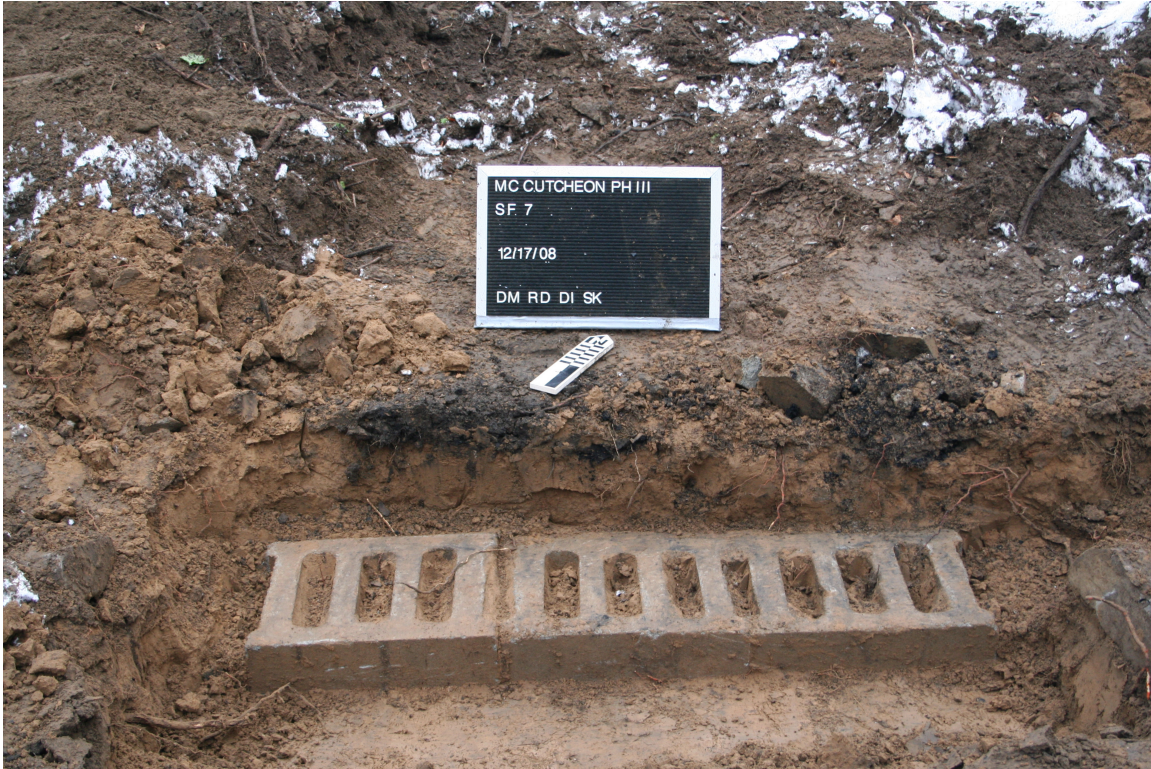
Photo 22. Completed excavation at base of SF-7.

This was a complex feature, composed of brick, stone and concrete block within a stain of 10YR 2/1 black silty sand. This feature was identified in the northern end of Area 2, and initially measured 20 x 20 cm (Figure 11, Photo 22). The feature appeared to be the remains of a linear wall of concrete block, probably associated with one of the two barns known to have stood to the north of the house. As the feature was being bisected along a roughly east/west axis, several additional blocks were noted beneath the initial block and brick, expanding the size of the feature to approximately 140 x 50 cm (Photo 22). The black sandy stain was shown to be ephemeral, measuring less than 2 cm thick. Because of the lack of stratigraphy, the feature was not drawn in profile.

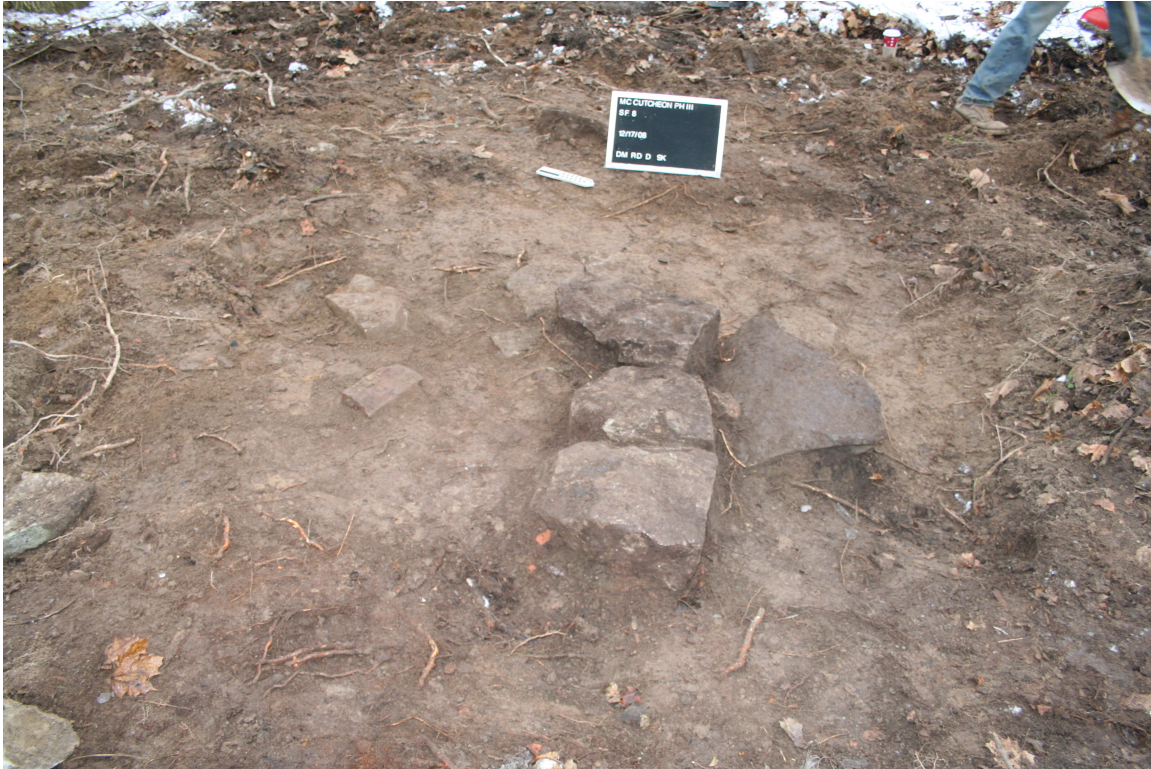
Photo 23. View of SF-8.

This feature consisted of a concentration of eight stones and a brick located along a level bench (Figure 12; Photo 23). The stones did not appear to have any specific orientation or linear arrangement, and no soil stain or other feature matrix was noted. The stones were removed in an effort to bisect the feature, but no other stones were recovered. A variety of artifacts were recovered from between and beneath the concentration of stones (n=57). Architectural refuse is represented by 26 fragments of flat window glass. Domestic refuse is small but diverse (n=8), representing undecorated whiteware, two kinds of yellowware and three kinds of stoneware. Other artifacts include food remains (n=3; bone and shell), beverage consumption (n=8; brown, clear and aqua bottle glass), a medicine bottle fragment, a piece of a whetstone, a plastic toy tire and a fragment of lamp glass. Also represented were an unusually high percentage of interior furnishings, including a fragment of wallpaper, two fragments of orange carnival glass and a fragment of green art pottery.

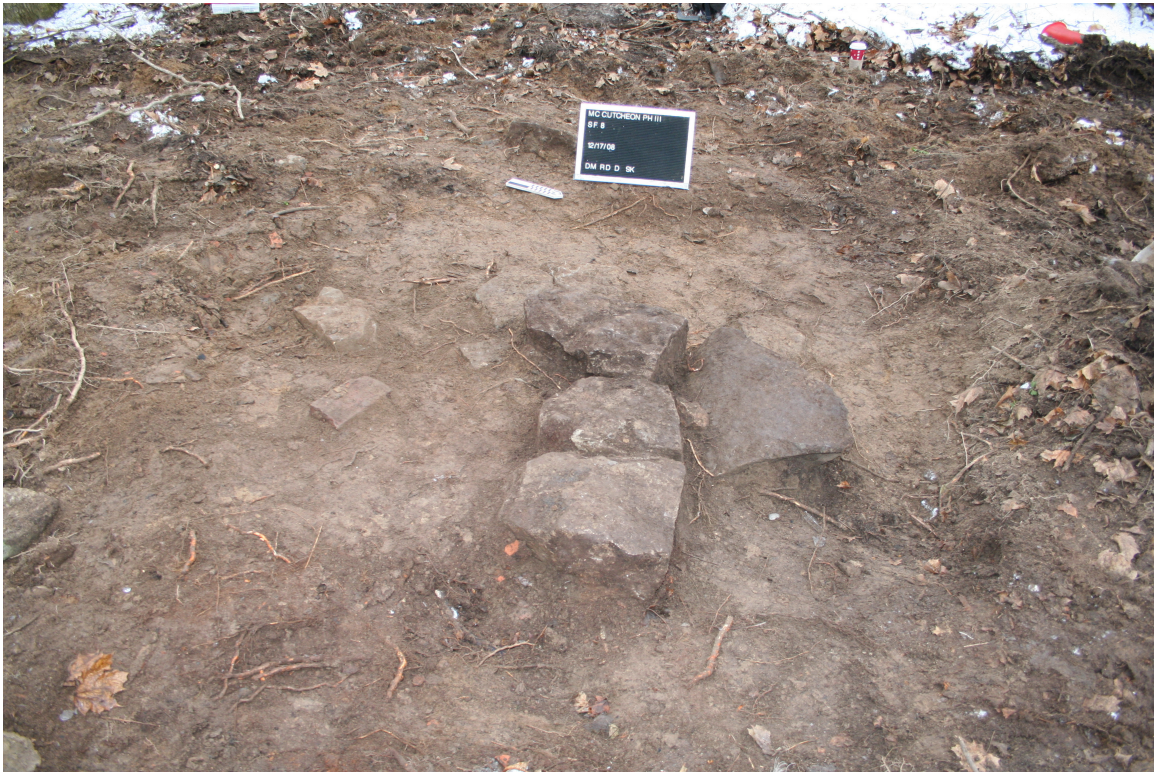
Photo 24. View of SF-5.

This feature consisted of a small cluster of large stones located in the northern part of Area 3. The stone concentration measured approximately 2.88 x 1.6 m in size and was roughly crescent-shaped, although the stones may have been in a linear arrangement prior to their identification with the backhoe (Figure 13, Photo 24). Only 10 artifacts were recovered from adjacent to these stones, including a fragment of flat glass, a mammal tooth, two fragments of oyster shell. A piece of hard black plastic and fragments of brown salt glazed stoneware and decal decorated whiteware. While this assemblage is relatively small it does reflect a diverse array of artifact types, including domestic refuse, food remains and architectural material. No other stones were encountered beneath those

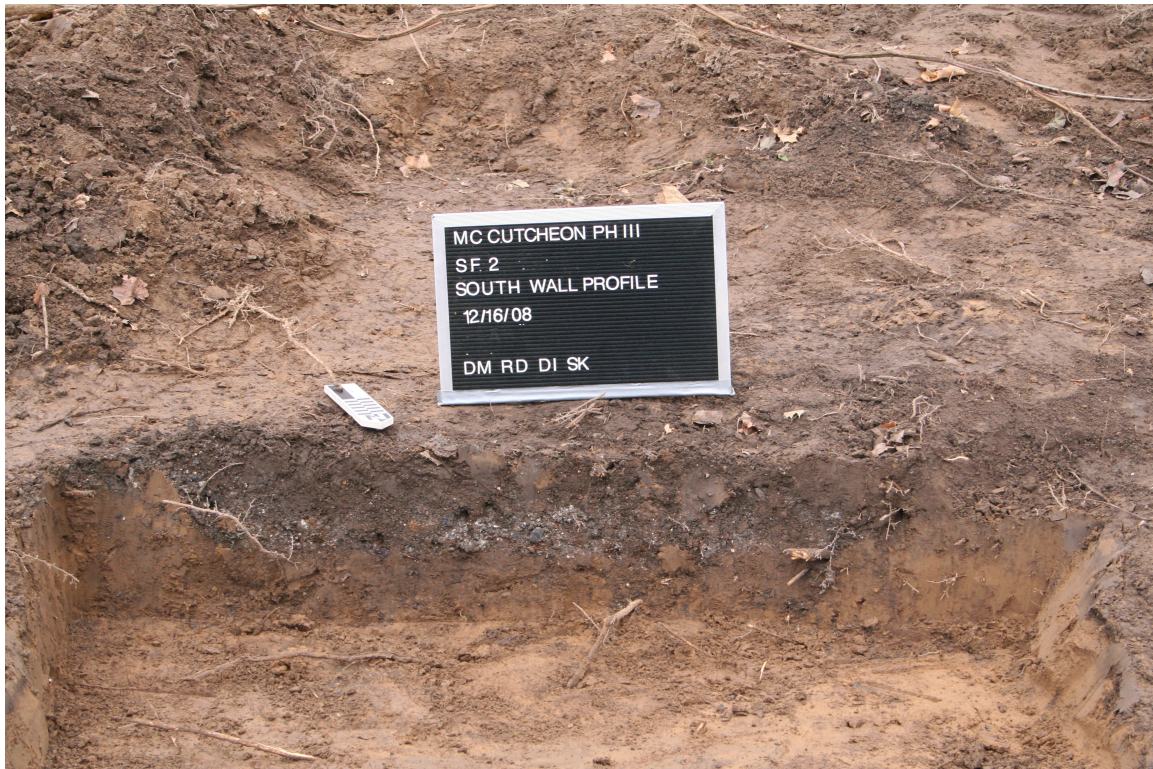
Photo 25. View of SF-2.

This feature consists of a coal and ash stain located in the western edge of Area 4 (Figure 14, Photo 25). The stain was roughly circular, measuring approximately 1.55 x 1.25 m. The feature was bisected along a roughly east/west axis, with the northern half being excavated for bisection. Bisection showed the feature to be approximately 12 cm thick, with a flat bottom and gradually tapering sides.

A total of 422 artifacts were recovered from SF-2, representing 60.8 percent of all artifacts recovered from the mechanized scraping. Most of the artifacts consists of architectural refuse, specifically machine cut and wire nails and nail fragments (n=290; 68.72%), as well as 53 fragments of flat glass, eight wood screws, two fence staples, a steel eye hook. Most of the other artifacts were classified as miscellaneous (n=40; sheet metal, unidentified iron, small glass fragments), with domestic refuse constituting only 19 artifacts (undecorated whiteware, hand painted porcelain, a "brillo" pad, two crown (bottle) caps and two fragments of clear curved glass).
