Archaeological Investigations at the
Peter McCutcheon Farm Site, Town of Bethlehem,
Albany County, New York

October 2010

A Phase III cultural resources data recovery was conducted at the Peter McCutcheon House Site, located in the Towns of Bethlehem and New Scotland in Albany County, New York. The site is a mid-18th century domestic and agricultural landscape, including a partially collapsed house, a pond, two barn foundations and several landscape features all within an area of approximately 1.26 acres. The Phase III study consisted of a full-scale mitigation of the site with unit excavations, mechanical scraping and structural dismantling in combination with documentary research centered on a series of research questions established in the Data Recovery Plan.

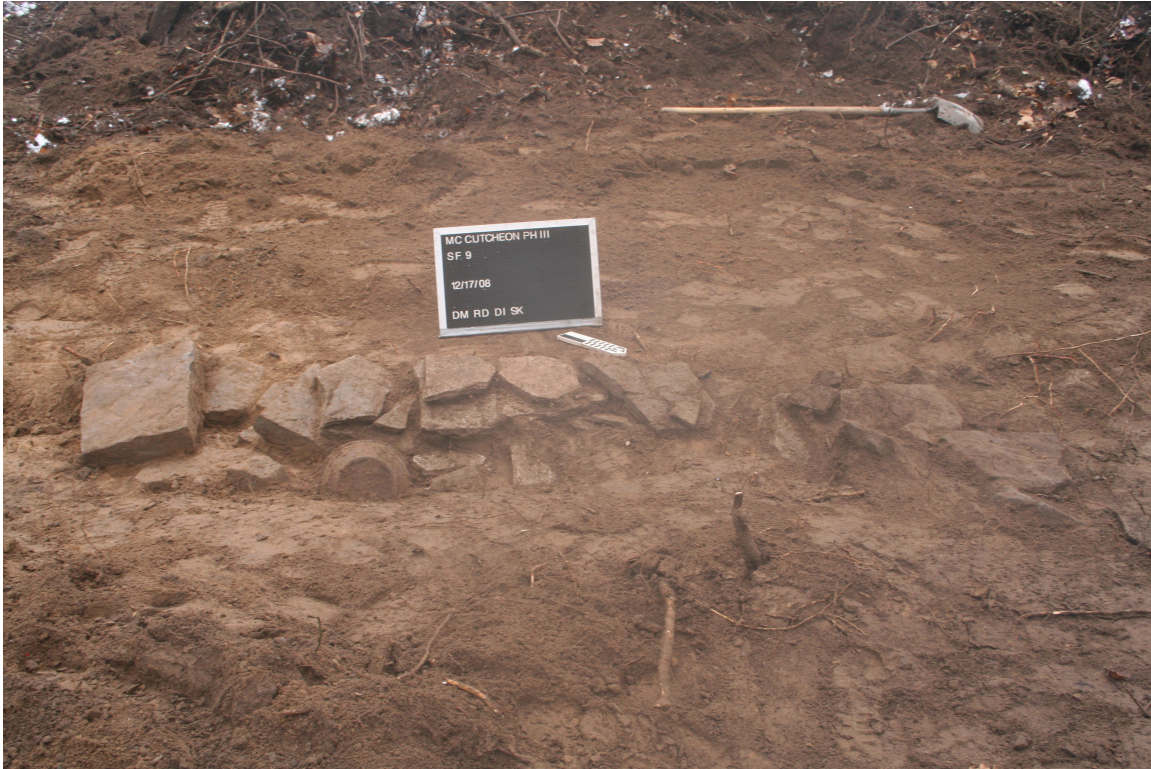
Photo 26. View of SF-9.

This feature consists of a linear alignment of large flat stones situated approximately 11.2 m south of SF-8 (Figure 15, Photo 26). This alignment appears to run parallel to the roadway on the east side of the house, and was oriented at 128 degrees southwest. The alignment was approximately 1.0 meter wide and 2.45 m in length. No other stones were noted during the cleaning of the feature and no dark staining was noted. A total of 23 artifacts were recovered from between the stones in SF-9 consisting of a divided mix of domestic and work related artifacts. Most notable within the assemblage is a large spittoon found between the rocks. Domestic artifacts include butchered cow bone, brown and clear bottle glass, fragments of ironstone, gray salt glazed stoneware and pearlware, a fragment of lamp chimney glass, a sherd from a whiteware teacup and fragments of an unglazed redware flower pot. Work and farm related artifacts include a scythe blade, an iron bar, fragments of wire, a machine cut nail and bracket or fragment from a piece of farm machinery.

This rock alignment likely represents an outline of a barn or other agricultural outbuilding. It would seem that the domestic artifacts represent dumping episodes adjacent to a building, while the scythe blade and other work/farm related artifacts likely reflect activities taking place within or immediately adjacent to the barns. The alignment of stones at 128 degrees is significant, since the presence of other stone alignments identified during the Phase II study were found at a roughly 38 degree axis, suggesting a 90 degree corner. The relative lack of naturally occurring large rocks within these sands makes these landform features easy to identify, although understanding their interrelationship can remain ambiguous.

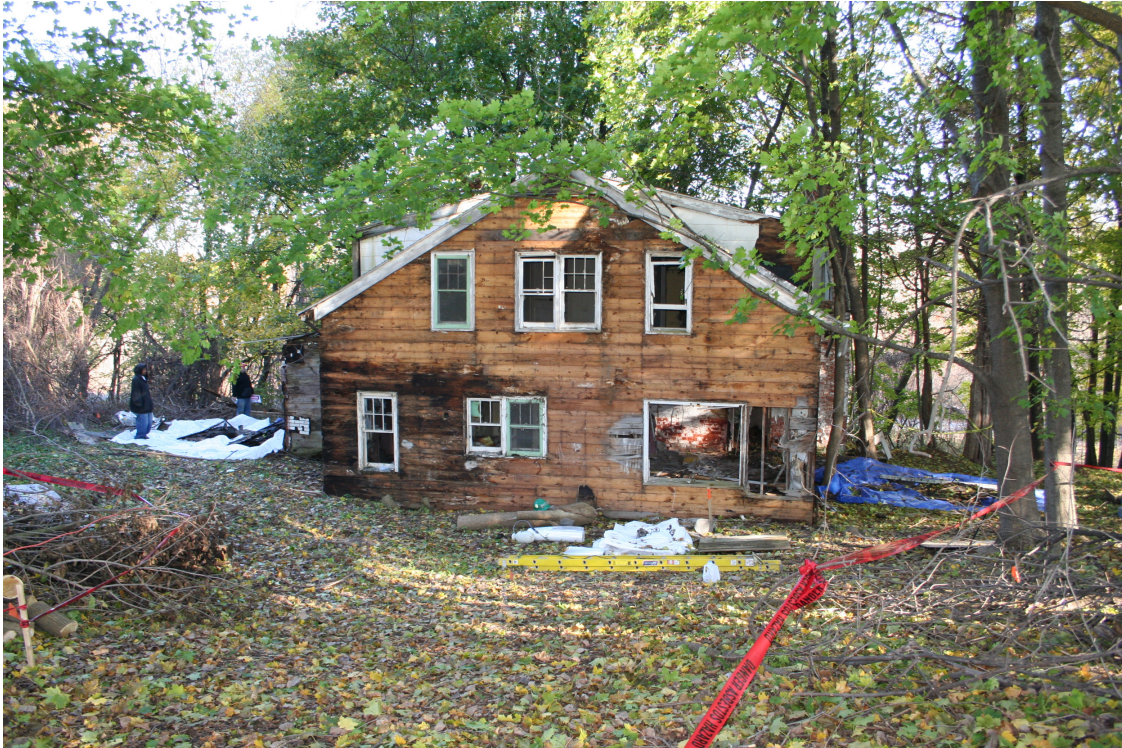
At the time of survey, the wood addition was in a dilapidated and partially-collapsed state (Photo 27). However, several diagnostic traits help to identify both a style and approximate period of construction. The wood-framed addition forms a shallow-pitched story-and-a-half cross-gable against the original brick portion of the house (Photo 2, 4 and 28). Windows in the addition vary from three-over-one light double-hung sash to six-over-one light double-hung sash. Several of the windows occur in adjacent pairs. Shed dormers extend from the gable ridge on both the southeast and northwest gable slopes. In each dormer an adjacent pair of six-over-one light double-hung sash windows provides light into the addition's half story. Asbestos shingles appear to have been the frame addition's original exterior wall covering. The shingles exhibit the popular wave line wood grain pattern that was first introduced in 1937 by the Johns-Manville Corporation (Hope 2004).

Photo 27. View of the McCutcheon House framed addition during the asbestos abatement process, facing northeast.

The frame addition was therefore likely added to the existing McCutcheon House in the 1930s during the Reilly occupation of the house. The addition follows in the tradition of the Colonial Revival style, an architectural trend popular during the late 19th and early to mid-20th centuries. As the architectural report completed in 1980 by the New York State Museum suggests, the addition bears patterns found in the early colonial Dutch houses of the Albany region, a hallmark of the Colonial Revival style:

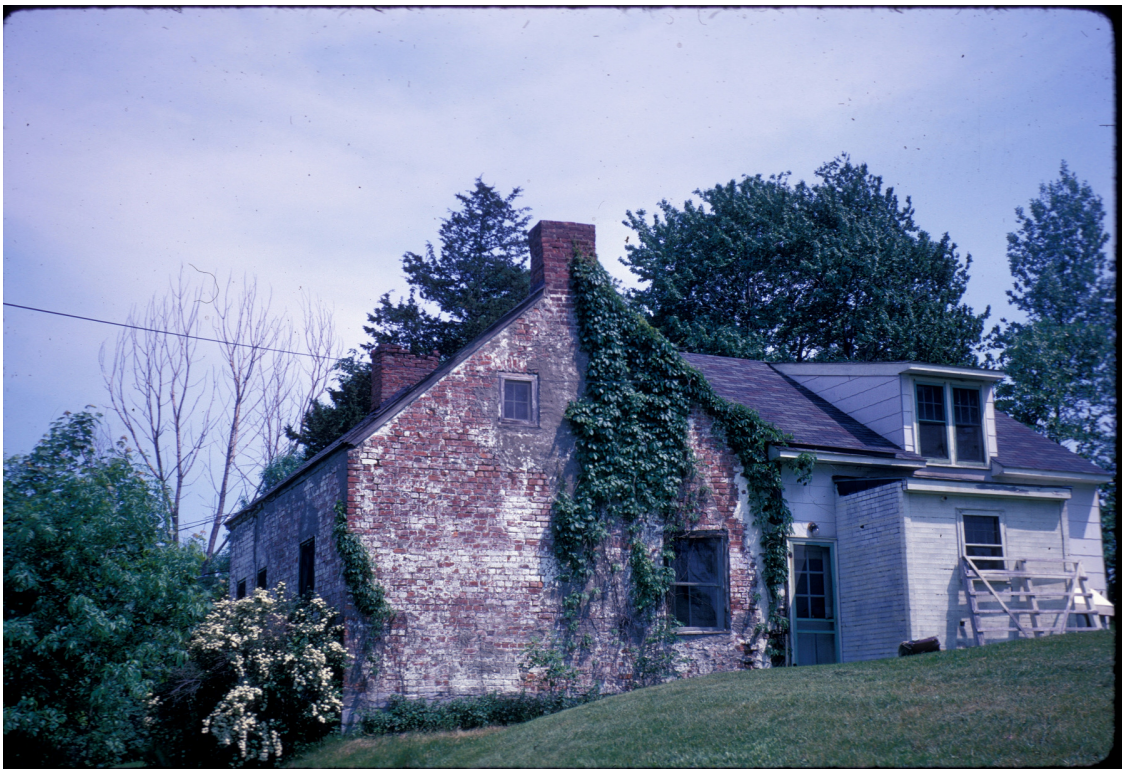
Photo 28. View of the McCutcheon House framed addition as it adjoins the brick portion of the house, facing south. Photo by Paul Huey, 1969.

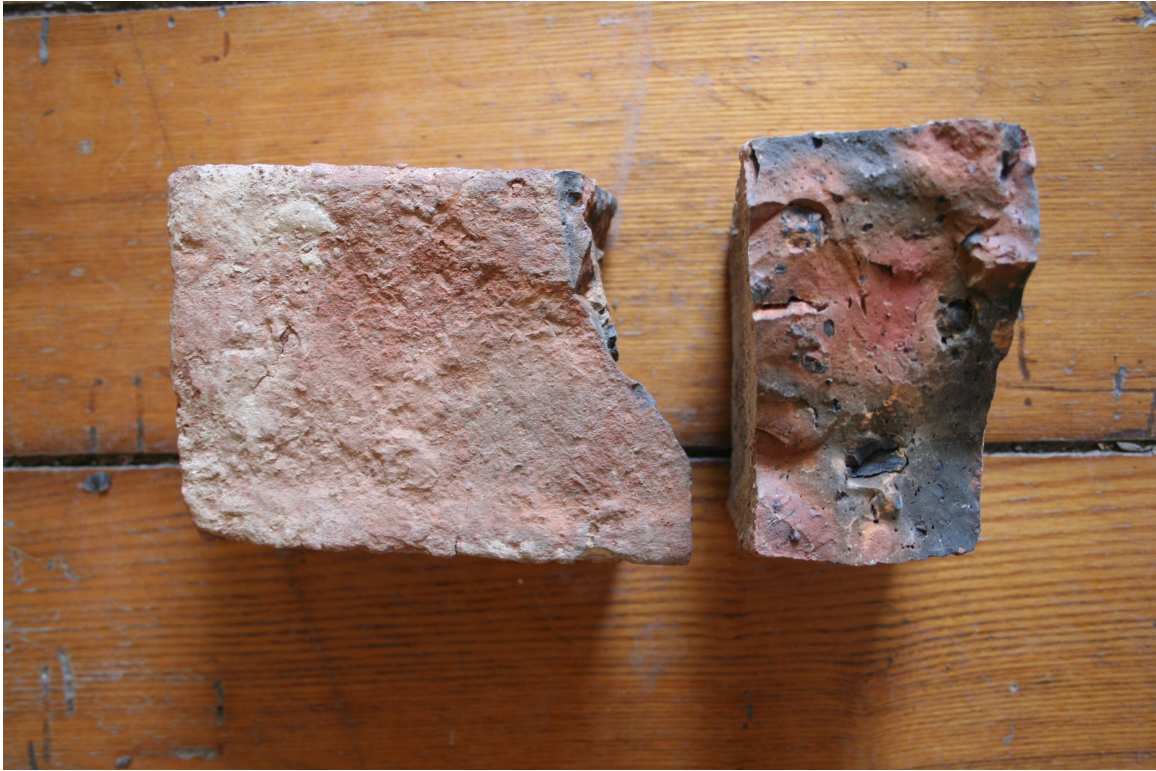
Photo 32. Large moppen bricks used in the construction of the McCutcheon House.

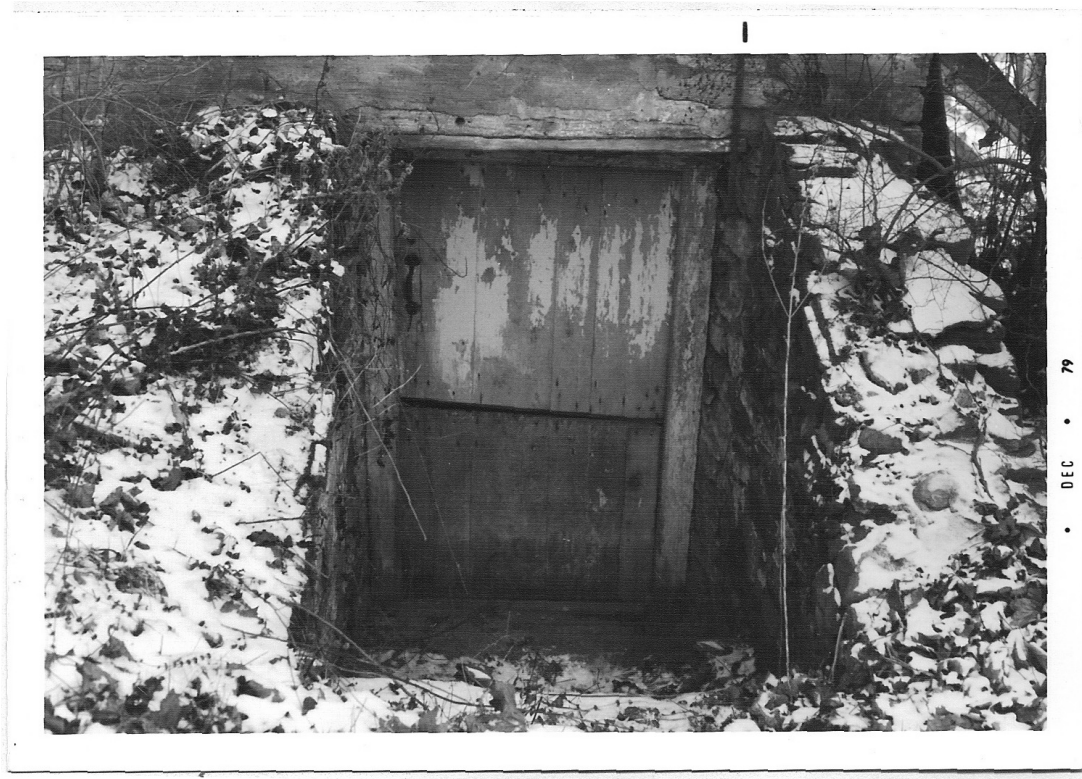
The McCutcheon House gable is shallowly pitched compared to earlier houses in the Hudson Valley and there is no decorative brick work, such as tumbling, or any evidence that the gable ends were ever parapet, a more commonly associated “Dutch” characteristic. Simple jack arches above the major door and window openings serve as the only exterior ornament. Access to the basement is provided on the southeast gable end where the ground begins to slope away from the building. The two-part, horizontally-divided basement door was perhaps the most notably “Dutch” part of the building. The door retained its original wrought hardware as seen in the photo below (Photos 33 and 34).

Photo 33. “Dutch” basement door of the Peter McCutcheon House, photo by Tabor and Cornell, 1979.

The south gable end façade was still largely intact upon assessment of the building. Only two windows occur on this elevation located on either side of the interior chimney stack in the upper half story. The placement of these windows is very similar to those in the upper half story on the opposite end; however, they are depicted in 20th-century photographs as having six-light fixed or casement frames. These windows may have originally been small four-light windows as on the other gable end and possibly lengthened in a later construction episode. In addition to the windows, the only exterior access to the basement occurs on this elevation in the northernmost bay. Four stone steps descend below grade to a two-part horizontal door commonly associated with Dutch building practices. The door had been removed by the time of mitigation, but historic photographs and existing hardware confirm its original presence (Photos 33 and 34).

The McCutcheon kitchen appeared to have only one access to the basement via an external “Dutch” door exiting the kitchen in its northeast corner (Photo 33). It is not clear, however, if this was always the only access or if wooden steps descended from the interior of the first floor at some point in the house’s history. No evidence of this second stair was found within the collapsed house.

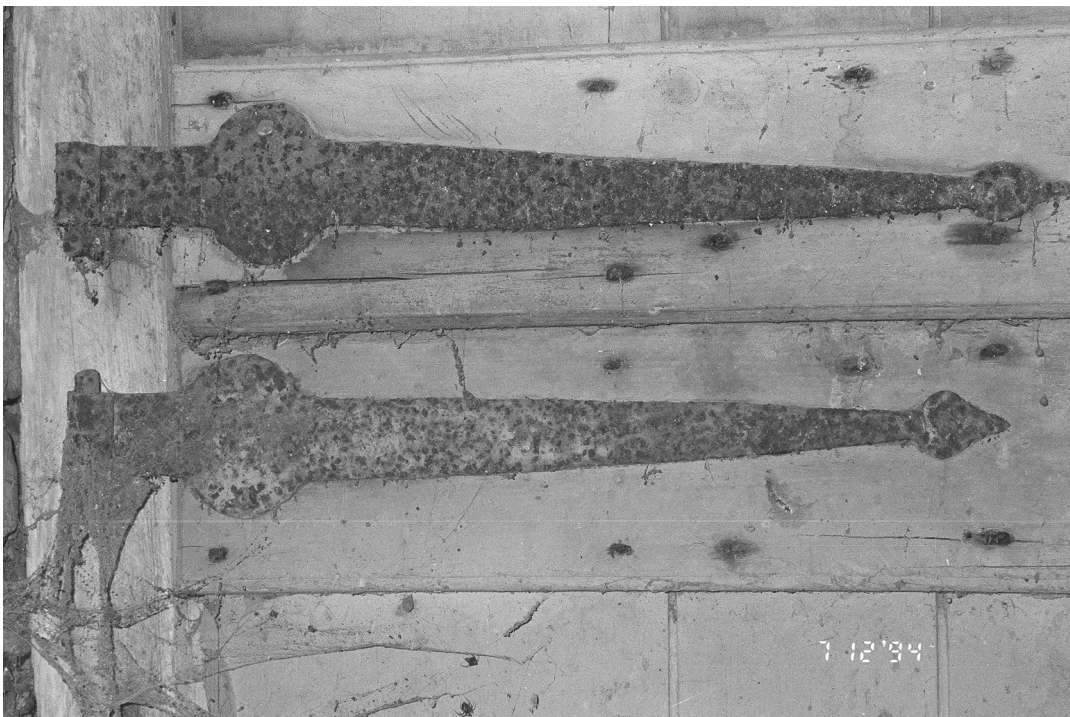
Photo 34. Detail of wrought iron strap hinges on interior of “Dutch” basement door at the McCutcheon House.

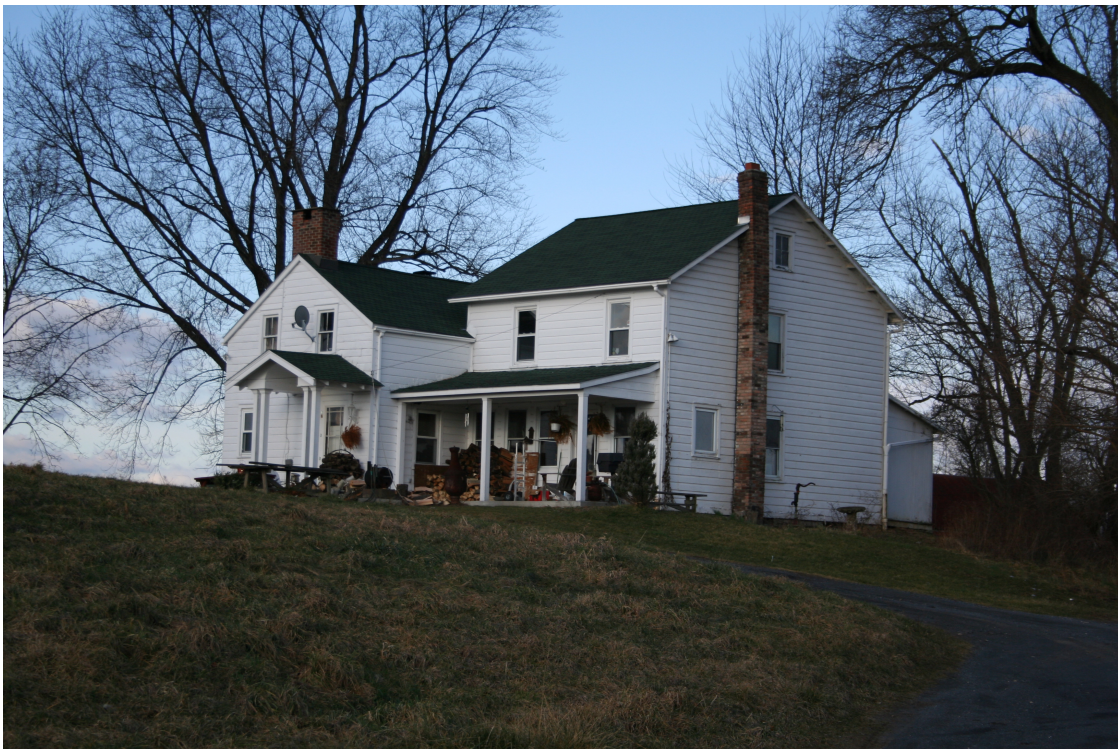
Photo 35. View of the LaGrange House, less than one half mile northwest of the McCutcheon House, facing west.

sections of the house, the enlargement of some window openings and the addition of chimneys. A cornice-band window on the only exposed gable-side of the original block, suggest the LaGrange house was built within the Greek Revival influence. Like the McCutcheon House, the LaGrange House also has a basement-level entry. The roof of the LaGrange House has no eaves, like the McCutcheon House and like other early “Dutch Colonial” houses. As Greek Revival houses typically had eaves, it is not possible without more in-depth study to know whether the LaGrange House roof was remodeled at some point to remove the eaves or if this design was an intentional decision on the builder’s part. The oldest section of the LaGrange House was likely built within 50 years of the McCutcheon House, although the two houses share few characteristics. The framed LaGrange House appears to be stylized with Greek Revival characteristics in a way that the brick McCutcheon House was not. However, both houses would have been simple in floor plan with only two or three rooms on the first floor and both houses feature an exterior access to the cellar.

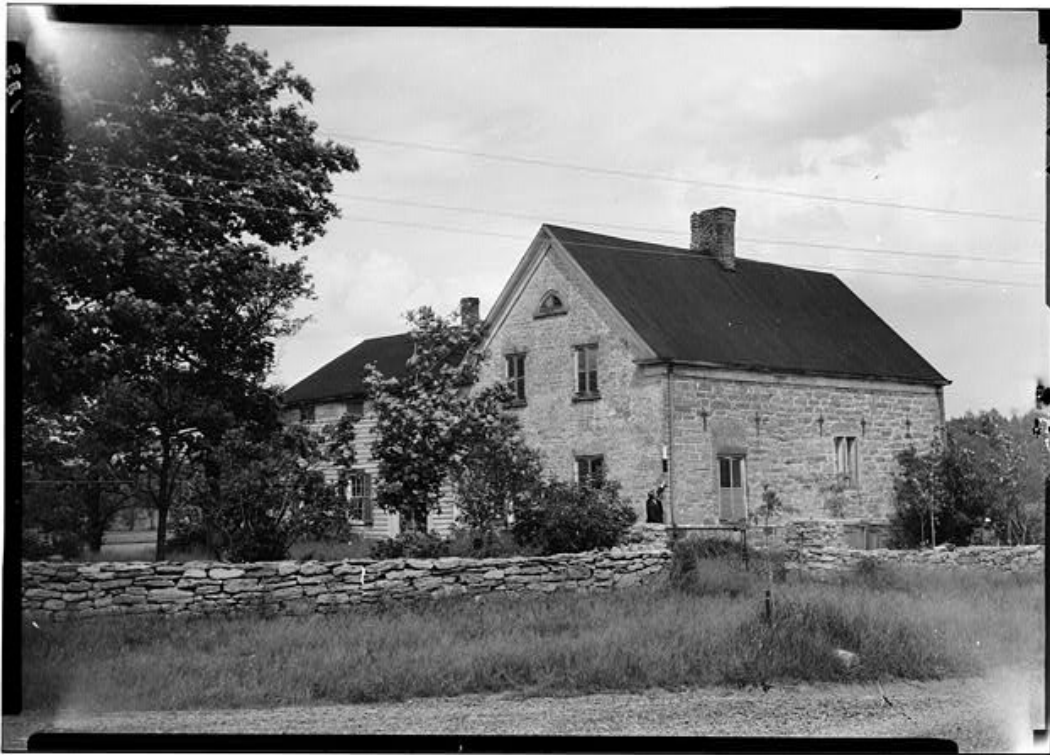
Teunis Slingerland, reportedly the first settler of what would become New Scotland, built a one-and-a-half story brick house in 1762 in Feura Bush, approximately five miles from the McCutcheon site (Howell 1886:77; Stevens 2005: 240-241). Like the McCutcheon House, the Teunis Slingerland House is constructed of brick and has similar massing in its original block (Photo 36). But unlike the McCutcheon House, Slingerland’s bricks were of a smaller, more common dimension. The Slingerland House is more overtly “Dutch” in its influence exhibiting decorative brick tumbling on the gable ends, jambless

Photo 36. Teunis Slingerland House, Feura Bush, Town of New Scotland , NY. Photo from the Historic American Buildings Survey Collection.

fireplaces, a moderate to steep roof pitch and one rubble stone façade (Stevens 2005:50, 240). However, being built nearly 100 years after the transfer of power from the Dutch to the English, there are also signs of English influence in the Slingerlands House. The brick tumbling on the gable ends is only decorative, while such tumbling on earlier New Netherlandic houses accented a parapet gable. Similarly, where earlier New Netherlandic houses might have used brick only as a veneer in front of a timber frame construction, the Slingerland House utilizes load-bearing masonry. The Teunis Slingerland House demonstrates that even among families of Netherlandic descent, colonial New York architecture in the second half of the 18th century was pluralistic and evolving.

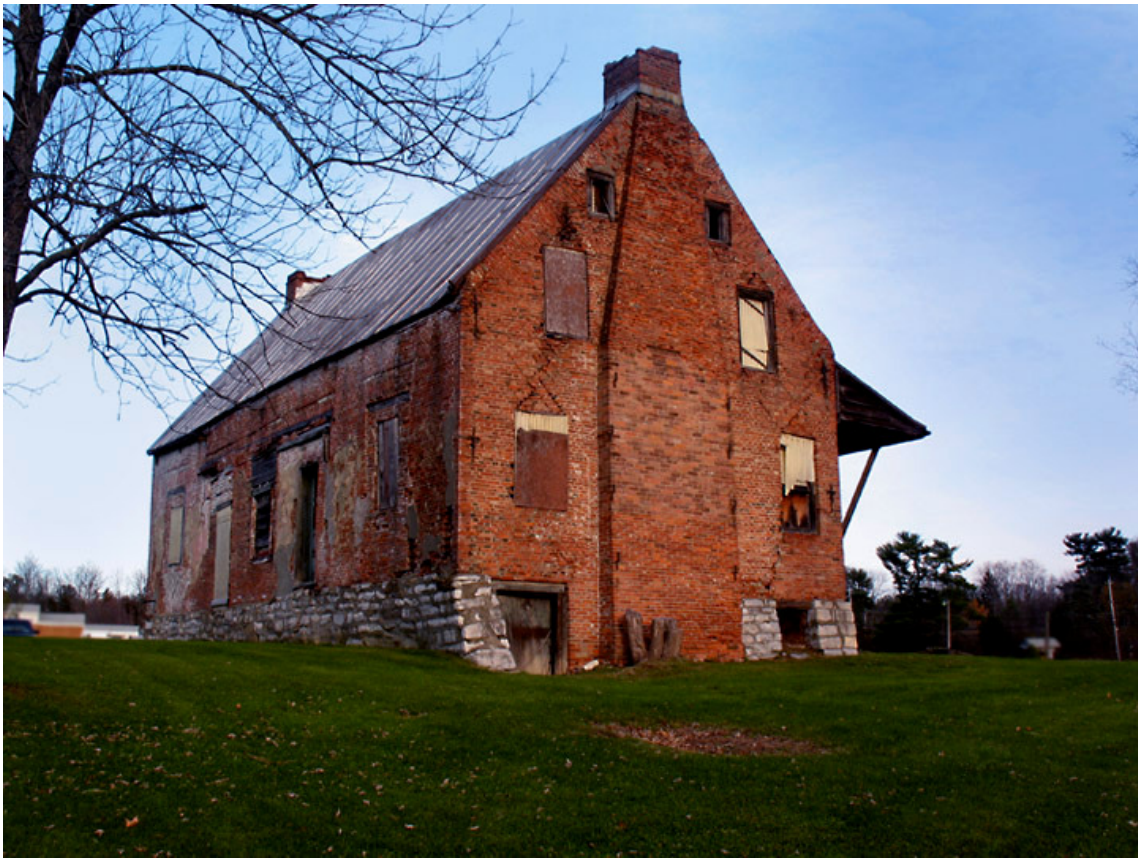
If the McCutcheon House does date to same period as its earliest timbers, it would have been built in the 1730s. Only a select number of brick houses in the Hudson Valley survive from this decade, the earliest of which being the Van Hoesen House near Hudson dating to circa 1730 (Photo 37). Other early brick houses that compare to the McCutcheon House in approximate size and massing are the Leendert Bronck House (1738) in Cossackie and the Luykas Van Alen House (1737) in Kinderhook. These three houses have remarkable similarity to one another including a wood frame structural

Photo 37. The Van Hoesen House, ca. 1730, near Hudson City, New York. The earliest known brick house surviving in the Hudson Valley. A metal roof added in the 19th century covers the distinctive parapet gables. A brick veneer covers the timber-frame substructure.

system covered by brick veneer, parapet gable ends and double entrance doors. The McCutcheon house had load-bearing walls and lacked any evidence of a parapet gable, putting it in stark contrast to the other period examples. Additional comparisons between the McCutcheon House and other houses built by or for tenants of Rensselaerwyck would add valuable information to what we already know. If the house dates to McCutcheon's time period, more research into the built environment of Scottish settlements in the Hudson Valley would add valuable information to the current research.

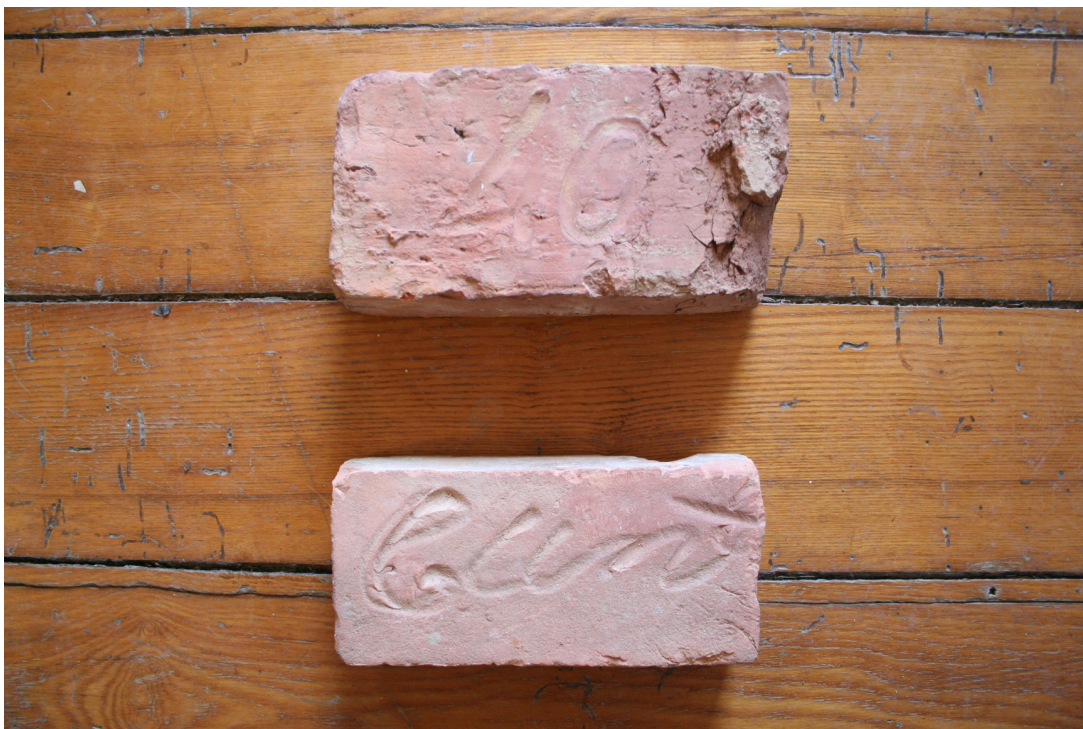
Photo 39. Large moppen bricks from the Peter McCutcheon House showing a) the inscription “40” and b) an incomplete inscription, possibly saying “Cutch.”

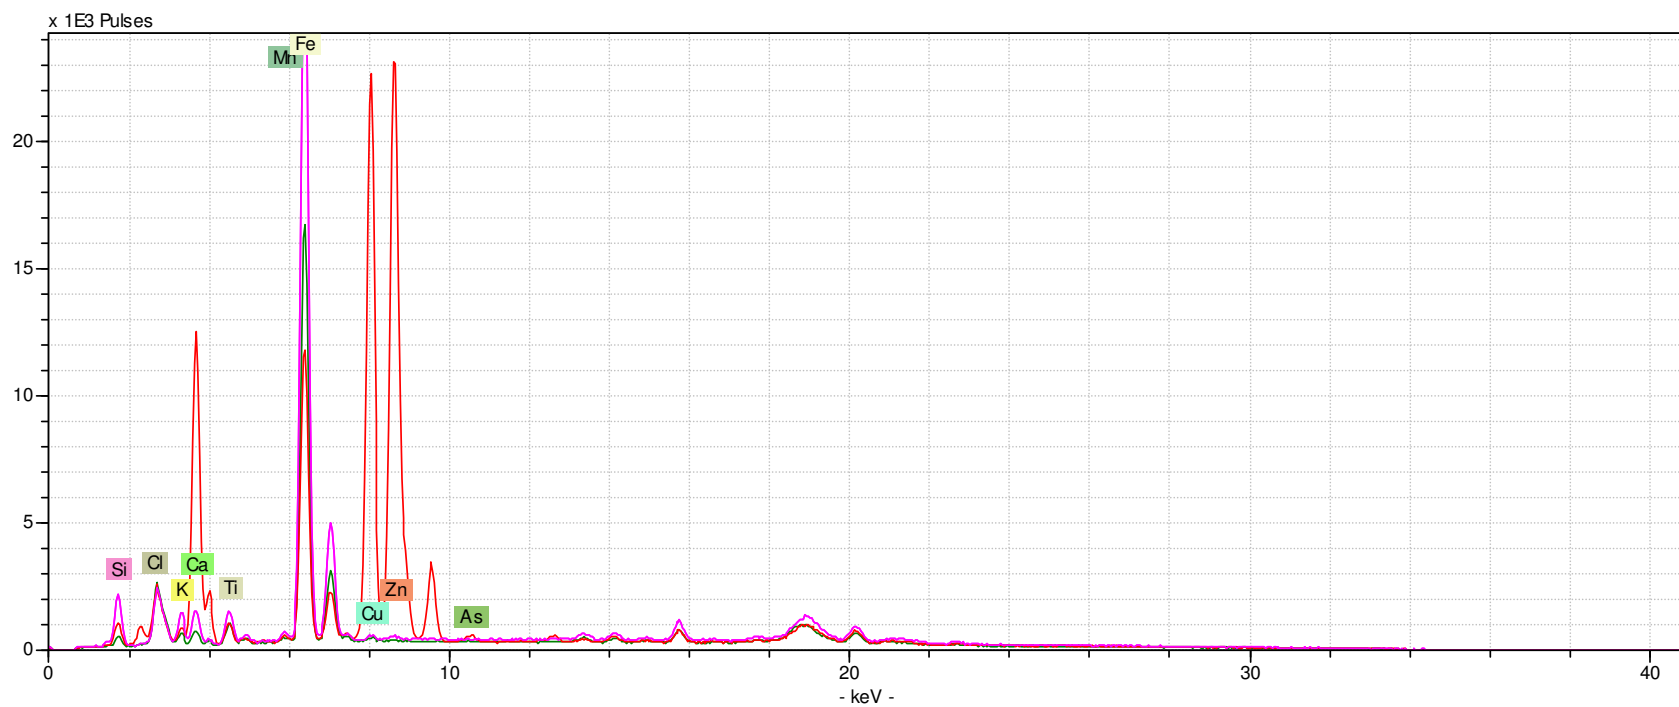
Graph 4. Elemental analysis of Brick 75. The graph represents all three readings taken from multiple locations on the brick. Although all of the bricks show a high range of elemental concentrations between samples due to the heterogeneous nature of handmade historic bricks , the relative peaks of the elements between the samples for each individual object were relatively consistent. Brick 75 is an anomaly, and may indicate that it was manufactured elsewhere.

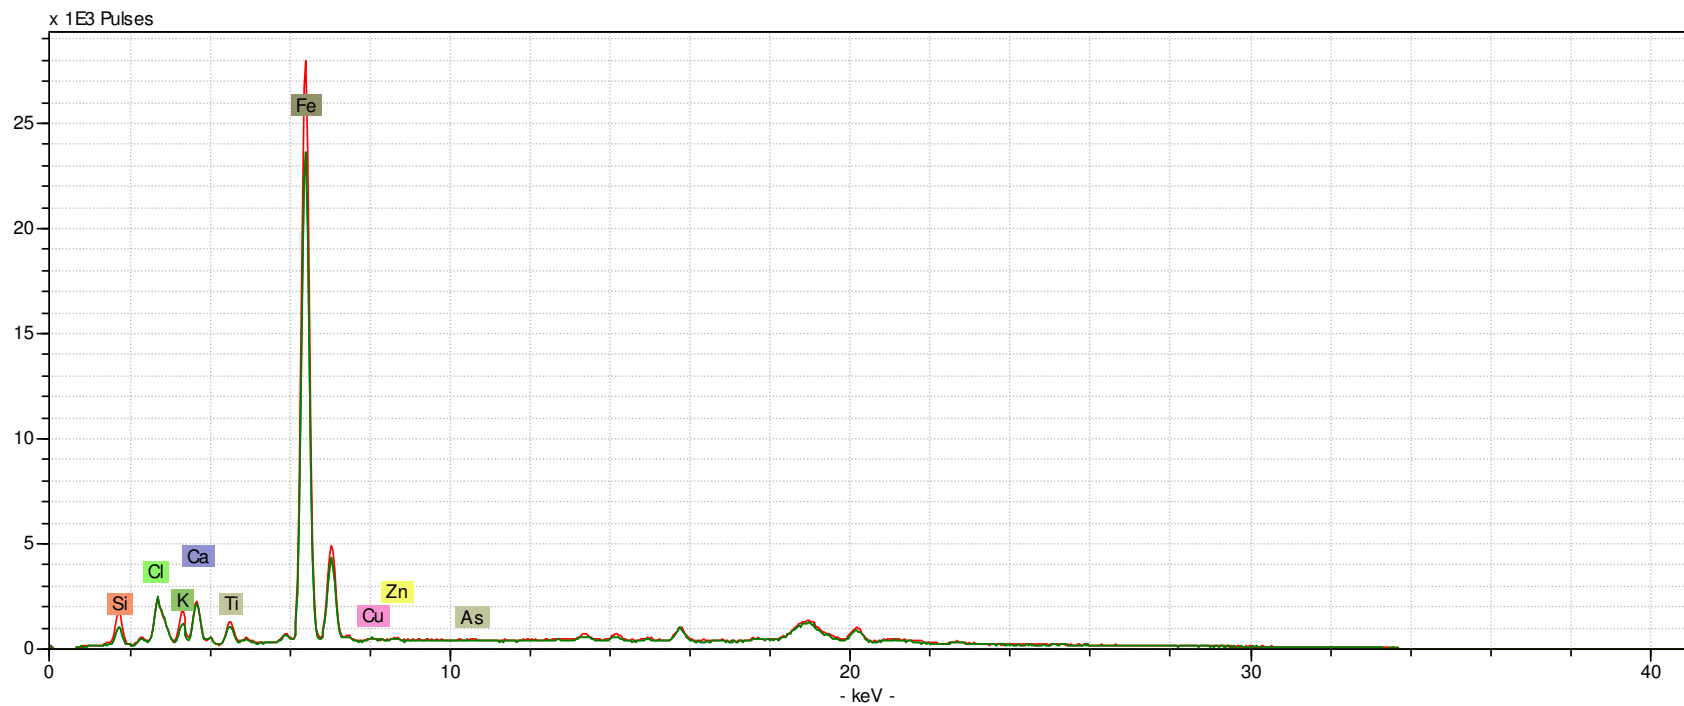
Graph 7. Elemental analysis of “English” style bricks found at McCutcheon House. Although stylistically different, they show remarkable elemental compositional similarities to the soil samples as well as other bricks recovered from the site.

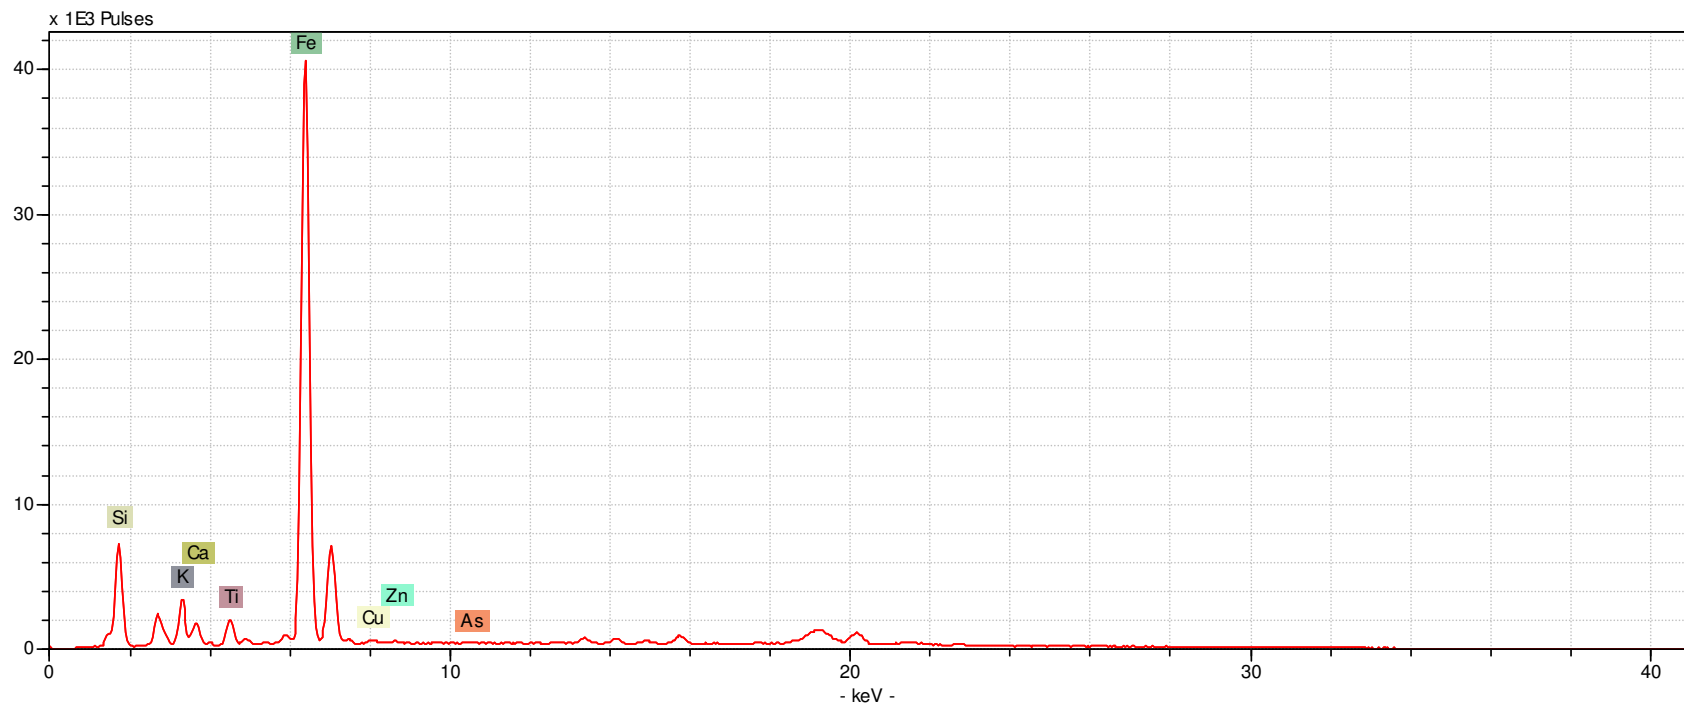
Graph 8. Elemental Analysis for the unknown temper found in brick. The elemental composition indicates that the temper is actually previously fired or waster brick from site.

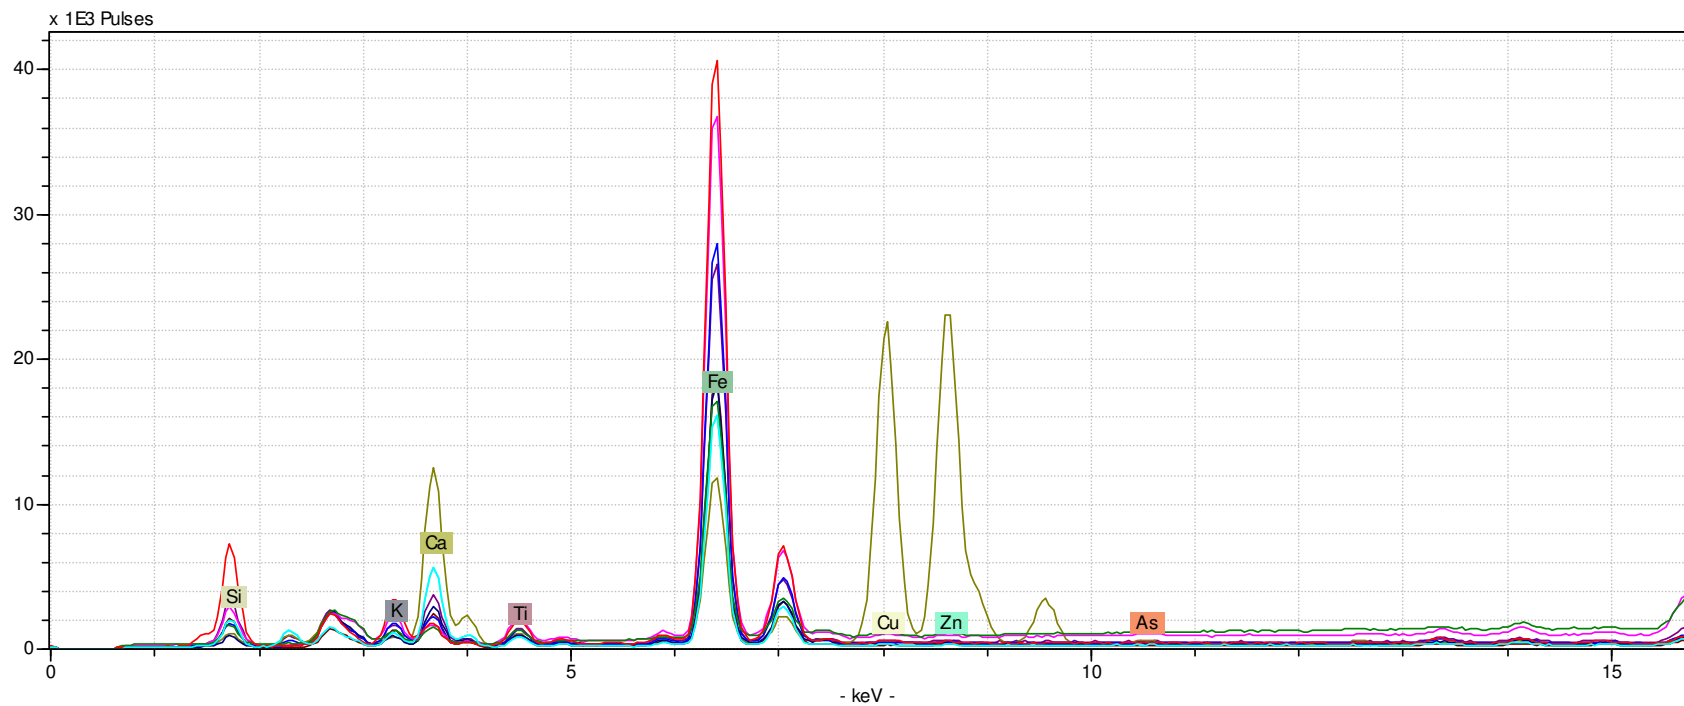
Graph 9. Results of all XRF elemental analysis readings of all bricks and soil samples. The samples exhibit remarkable similarity, with the exception of Brick 75, represented by the khaki line in the graph.

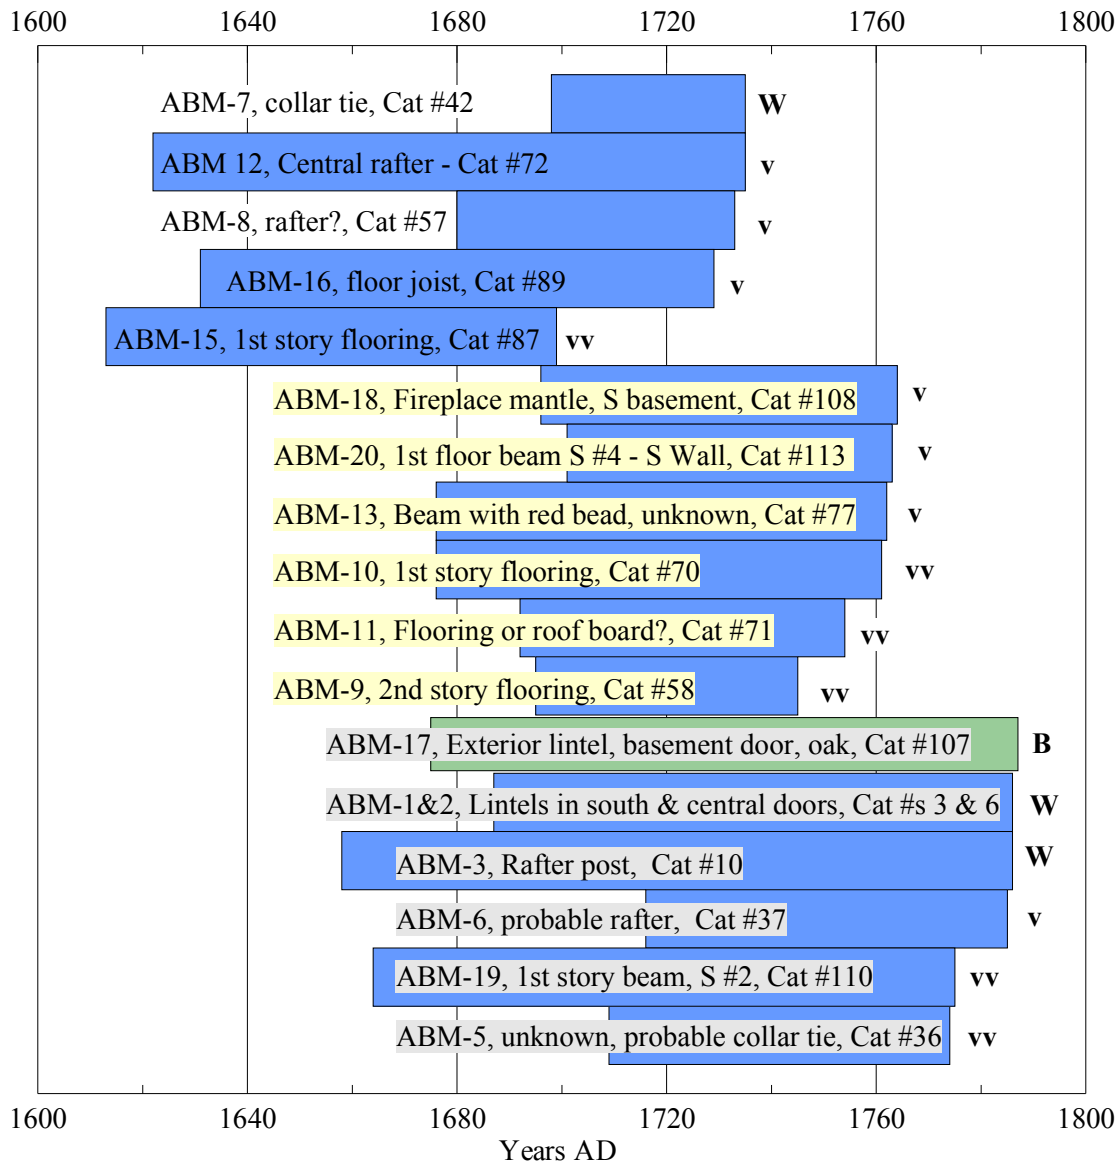
Figure 1. Here are the ranges of dates covered by each dated sample. Blue bars are the pitch pines; the green bar represents the one oak sample. The letters on the right side of the bars are explained in the text above.

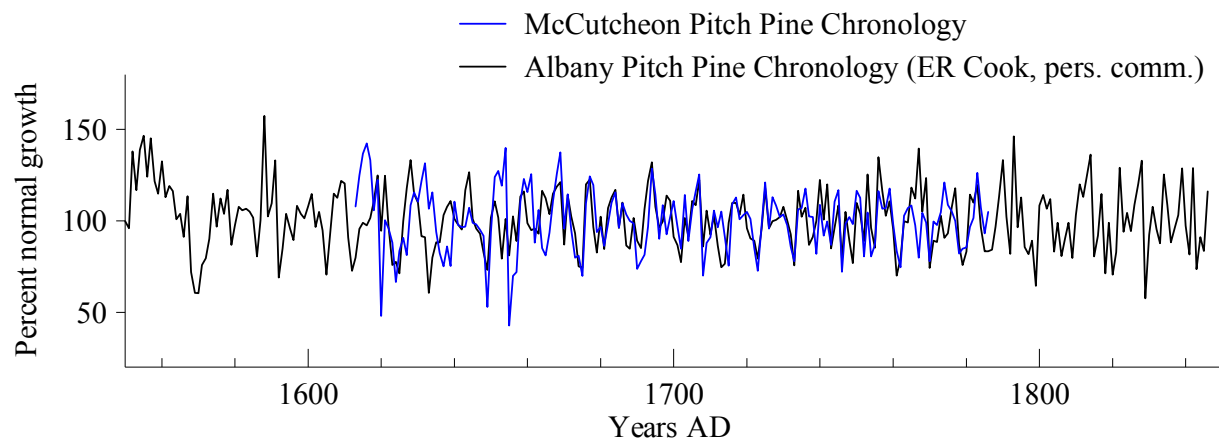
Figure 2. Above are the McCutcheon pine chronology and a regional pitch pine chronology from samples found in six other buildings around Albany, NY. Both the visual comparison and statistical tests indicate that this is a secure crossdate at the 95% level.
