# **An Archaeological Survey of Three Historic Industrial Cement Complexes in Rosendale, New York.**

David Moyer  
Upper Susquehanna Chapter, NYSAA  
Chenango Chapter, NYSAA

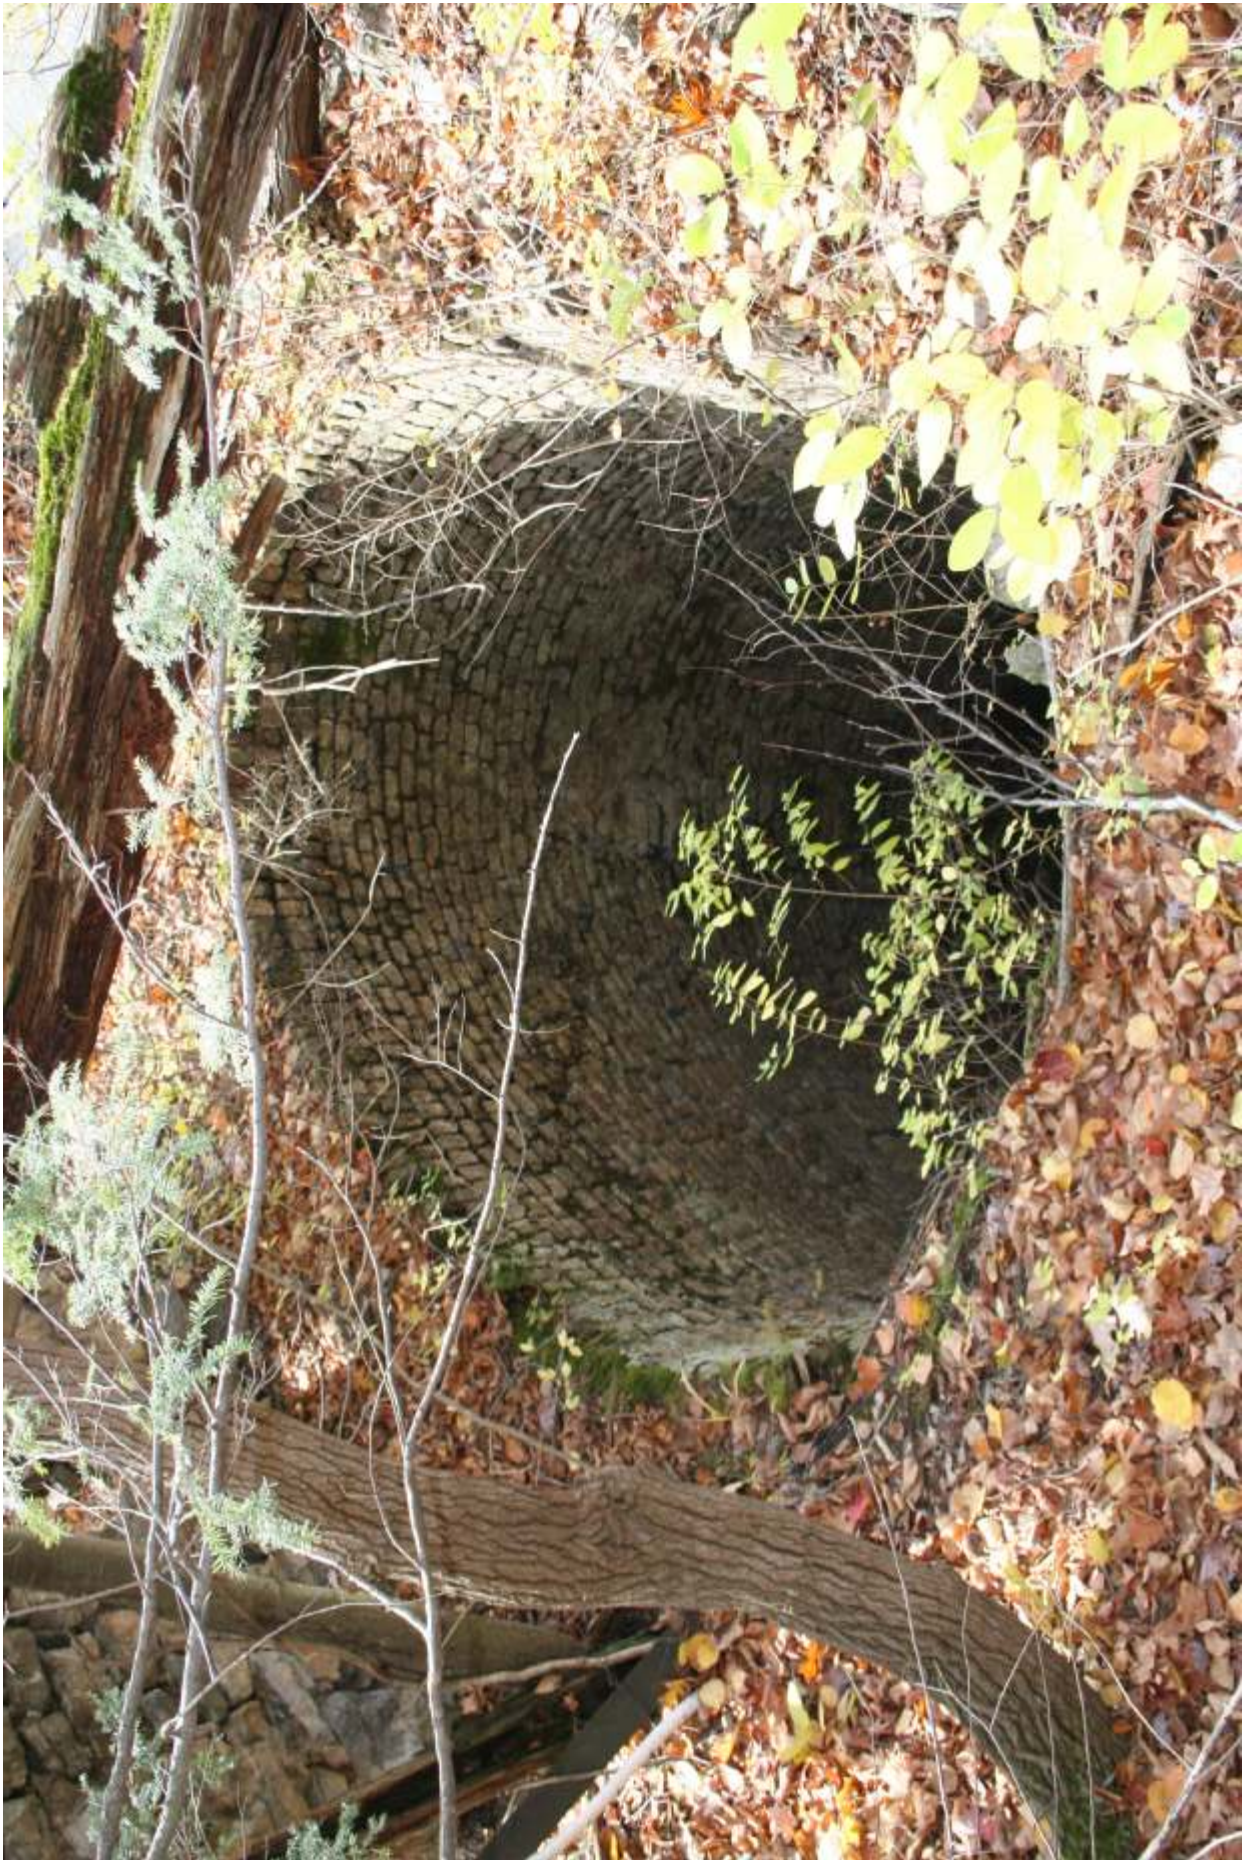
FIG. 12

We are very fortunate to have several sources of documentary information about these cement factories, including Sanborne fire insurance maps (Figure 10), historic photographs of some of the mill buildings (Figure 11), and old advertising (Figure 12). Archaeological remains associated with the three cement complexes include kilns (Figure 13), chimney stacks (Figure 14), and the remains several structures, including a barrel shed (Figure 15), and stone warehouse and barrel making structures (Figure 16).

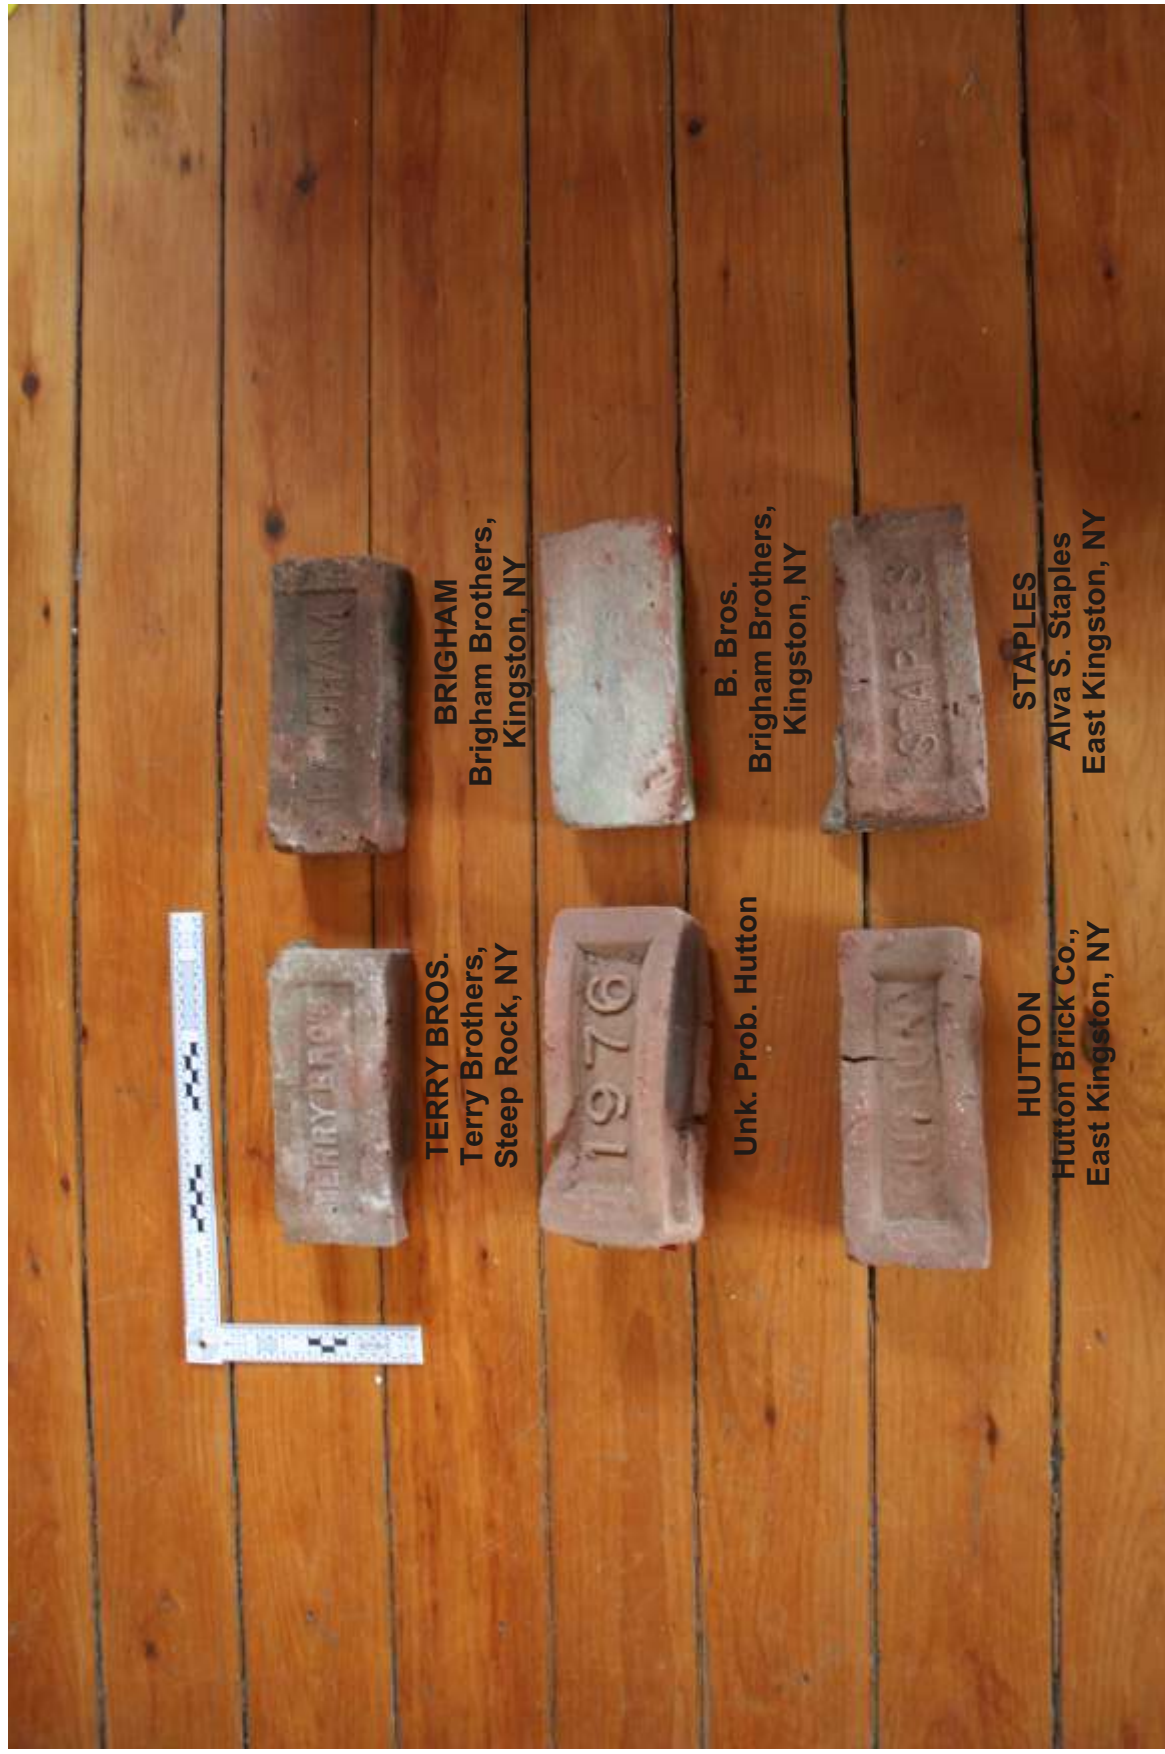
# Common Brick

Many of the bricks encountered were marked Brigham (Figure 26). Henry R. Brigham was an Agent for A.J. Snyder & Son's Crescent Brand Rosendale Cement. His father was the founder (in 1858) of the Rosendale & Kingston Cement Company later known as the Hudson River Cement Company. "H.R." worked for his dad's cement company. H. R. formed Brigham Bros with his brother William H. they manufactured bricks from works next to the Hudson River Cement Co. in East Kingston. Around 1891 H.R. became general agent for A.J. Snyder & Sons. A few years after the death of A.J. Snyder (in 1902) he also became the superintendent of the Snyder Cement Works in Lawrenceville.

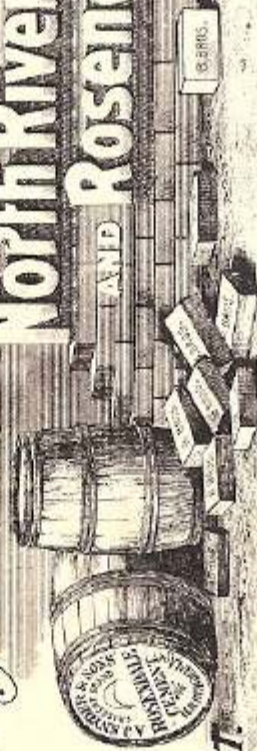
# Henry R. Brigham

Manufacturer and Manufacturer's Agent for

## North River Brick AND Rosendale Cement

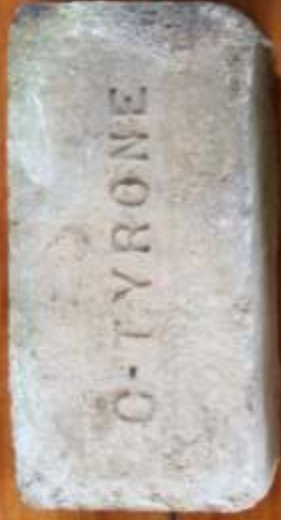
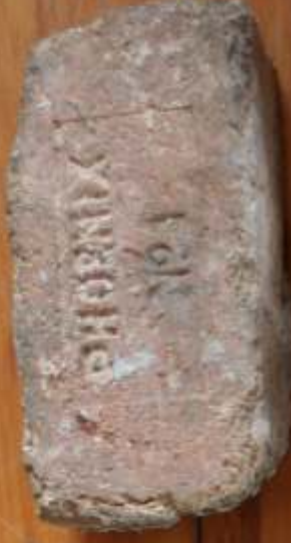
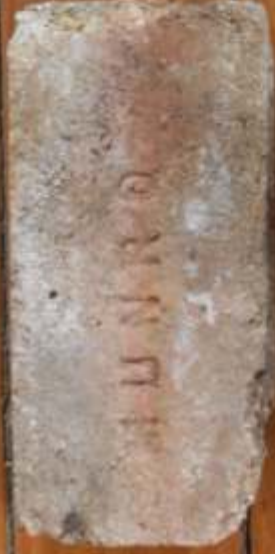
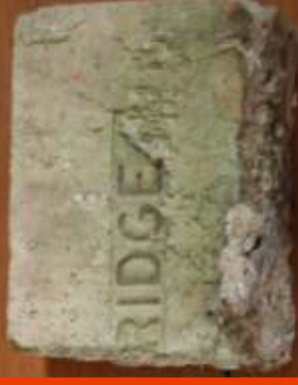
# FIRE BRICK

**C-TYRONE**

**PHOENIX No. 1**

**MUNRO**

**Harbison-Walker  
Refractories Co. PA**

**RIDGE  
General Refractories  
Company PA**

Results further indicated what while marked common bricks show a strong correlation with regard to the individual kiln walls, fire brick was comparatively homogeneous (Figure 27). Also, little variation was noted within the kiln walls, specifically with respect to the breaks in the stonework that we think indicate later construction episodes. This lack of variation between kilns thought to have been constructed at different times is not too surprising since the fire brick lining of the interior kiln walls had to be replaced every few years after near continuous use. Thus, while the kilns themselves might have been constructed at different times between the 1860s and when plants ceased operations in 1926, the fire bricked interior lining of the kilns themselves all date to within a few years of one another.
